RESEARCH ON THE SAFETY LEVEL OF THE EXISTING ELECTRIC TRACTION ELEVATORS

Tihomir DIMITROV, Georgi ILIEV, Kalin CHUCHUGANOV, Pavel DAVIDOV

Engineering logistics, material handling, building and roadbuilding machines department, Technical University-Sofia, Bulgaria

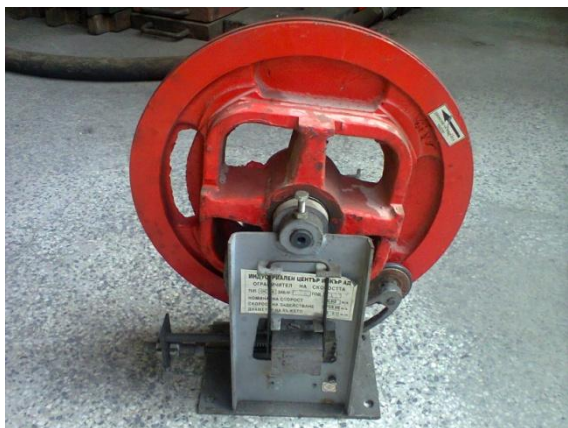
Picture 1: Overspeed governor of the type most commonly used

Other key safety component is the overspeed governor. First problem ascertained is the missing seal on the adjusting screw. The tripping speed of the device is not guaranteed in these conditions. During the research it was proven that where the seal is missing these governors are not tripping at the necessary speed. If we consider the braking distance of well working safety gear of only few centimeters, we have to pay special attention on this fact. The reason is the limitation on the acceleration levels during the emergency stop of the car by the means of the instantaneous safety gears used. This limit is average 25 m/sec^2 , and peak value of 30 m/sec^2 according to the requirements at the times of design and manufacture of the units. As experimentally is proven that the braking distance is 15 mm approximately, these limits means that the maximal tripping speed and maximal nominal speed of lifts when using this type of safety gears are limited to the following values:

The other safety related problem found during the research with the system of the overspeed governor was the missing tension of the governor rope mainly in one of the types of diversion pulleys used. The affected type of the diversion pulley is with spring force and without safety contact used. The problem is based on elongated rope and as a consequence exhausted move of the tension mechanism. In this case the necessary tension in the rope of the system is not provided and thus the system is not working at

The first problem with this safety device is the tripping speed. The seal on the tripping speed adjustment screw is missing. The real tripping speed is quite higher than the needed one in few cases. The related risk is high- in case of need the acceleration caused from the activation of the safeties will be higher than the limits. Not only this, but there is additional risk based on the fact that the safeties have maximal tripping speed and their proper work is not guaranteed for higher speeds.

Other serious problem is with the not enough tension of the governor rope because of elongated rope and as a consequence exhausted move of the tension mechanism. In this case the problem is the same- again the safety gears were not activated during the tests.

5. Replacement of the old spring type governor rope tensioning devices with the newer one, where tensioning weight and safety contact are used in order to achieve higher safety level and to decrease the possibility of failure of the overspeed governor work.

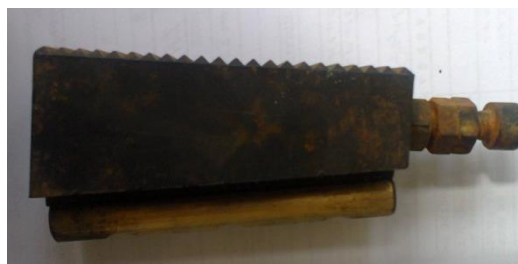
Picture 3: Toothed wedge

The main identified problem in the face of safety is the not working safety gears of one of the types used. The problem type is toothed wedge safeties, as it was described in 2.12. Picture 3 illustrates the key part of this type of safety gears- toothed wedge, which have to react with the guide rail.

The construction of this wedge contains two parts, as it can be seen from this picture as well. They are steel toothed body and bronze sliding part, bolted on the back. The toothed part is the working surface of the safety block while the bronze sliding part is in contact and is purposed to glide with the safety block body. The condition for proper work of this device is to provide self wedging. This is possible when the coefficient of friction between the toothed part and the rail is bigger than the one between the safety block body and the bronze slide. On the Figure 3 is shown schematic of acting forces of this type of wedge safety block. Here bellow are the formulas for force analysis of this type of safety gear and finally the explanation why this dependence of coefficients of friction has to be fulfilled.

It was surely proven by the survey and tests that in all the cases where the bronze slide was clean and properly oiled or greased and the toothed surface was clean and without grease and dirt the safeties works as it is necessary. On the contrary, in all the cases where the toothed surface was dirty or greased the safeties doesn't work at all. During the tests it was not possible to activate them even after 5 attempts.

In order to analyze the reason it is necessary to mention other aspect of the problem. The dust and dirt on the toothed surface is mixed with oil from the rails. In the problem cases this dirt covers completely the entire height of the teeth. This new surface provides different coefficient of friction than the designed one, definitely lower one. In the same time on the back we have again dust and dirt from the years of operation and again we have different coefficient of friction than the necessary according to the design. As it was cleared from the formulas above, the reason for not working safety gear of this type in these conditions is in the non realizing the self wedging process because of reduced coefficient of friction between the working surface of the wedge and the rail, and in the same time the changed (most probably raised) coefficient of friction between the bronze slide and the safety block body. Because of all these changes, the self wedging is not happening and the wedge just sliding on the rail.

It was proven the main reason for this is the not performed operations according the manufacturer's instructions. The safeties with the wedges were not clean and properly oiled. The frequency of appearance is high- each of the problem units has this problem. The related risk is also very high- in case of need this safety device will not block the car to the guide rails.
