TOSHIBA THE 60TH SERIES ANALOG COPIERS – A FINAL ANALYSIS OR WHICH ARE THE MOST COMMON AND MIND SCRATCHING PROBLEMS IN THESE MACHINES.

TOSHIBA 1350/1360/ 1370

TOSHIBA 1550

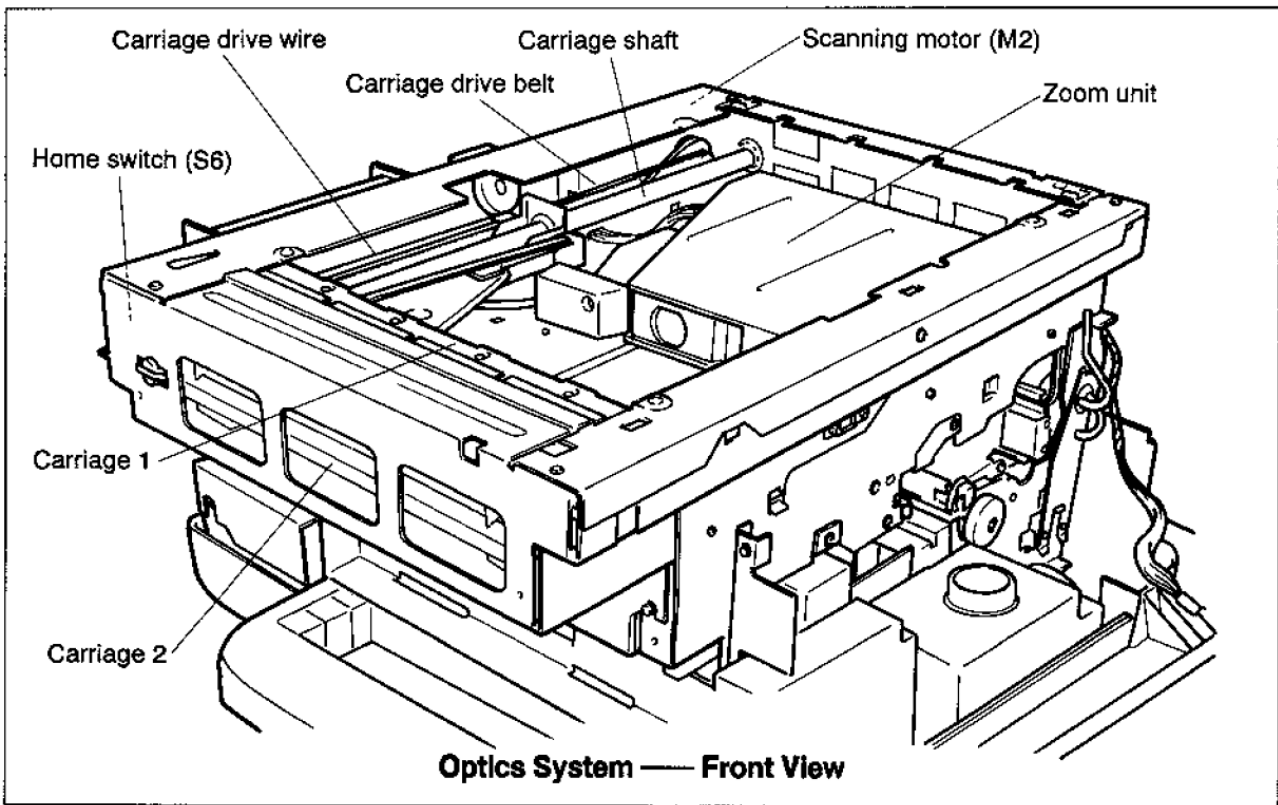
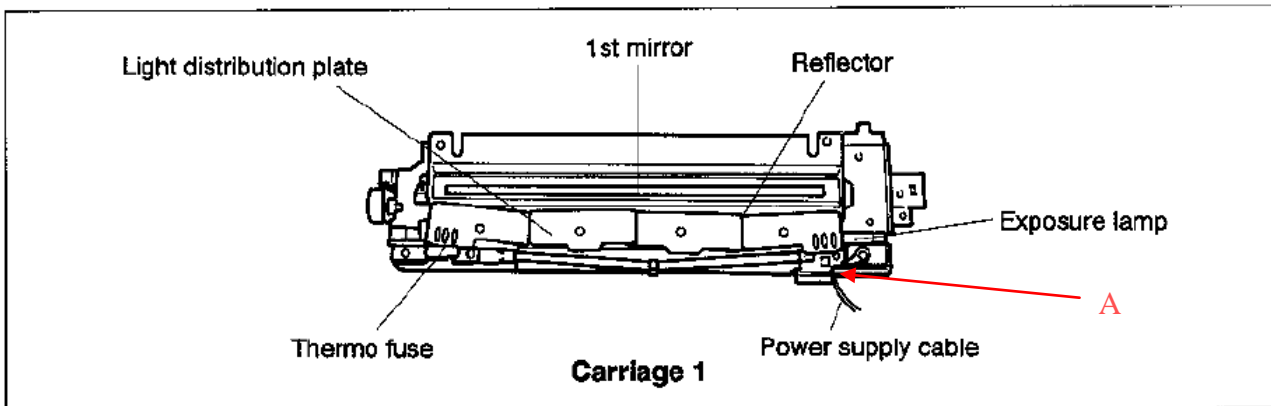
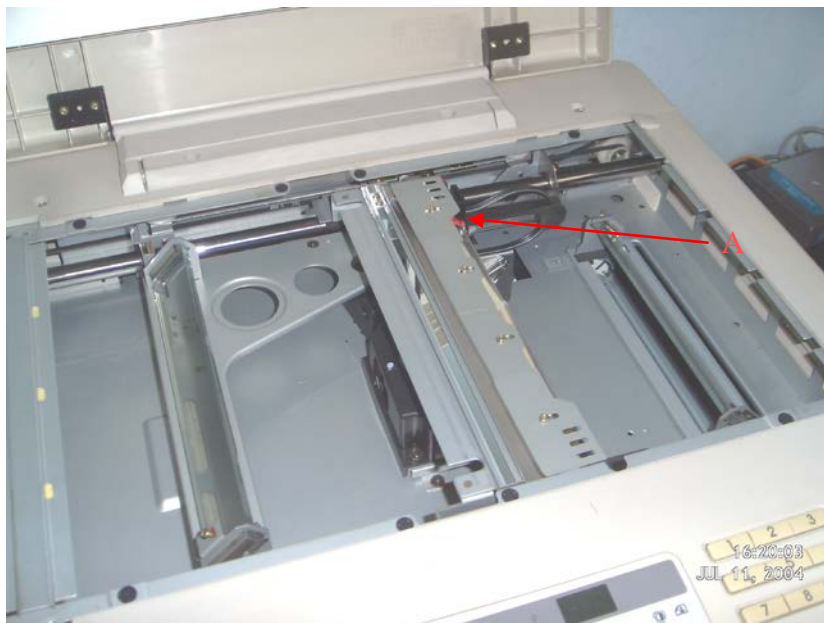
OPTICS MODULE

As shown on the pictures bellow, the optics module consists of 3 carriages. Carriages 1 and 2 slide on a carriage shaft. You should always check it and lubricate it if necessary.

Another very common and unpleasant problem, both for the service technician and the machine, is the exposure lamp power supply wire. Due to its design the wire is bent repeatedly during scanning of originals, as the carriages move. This leads to deterioration of the wire's insulation and after a while a short circuit directly into the main power supply unit, as the expo lamp operates directly on 220V AC. If this happens you will have to replace the wire, which is quite time consuming repair. If you are unlucky enough you will have to repair the main power supply unit too. To prevent this, always check this wire in spot A. Usually the crack in the wire is not visible, as it occurs on the underside of the wire.

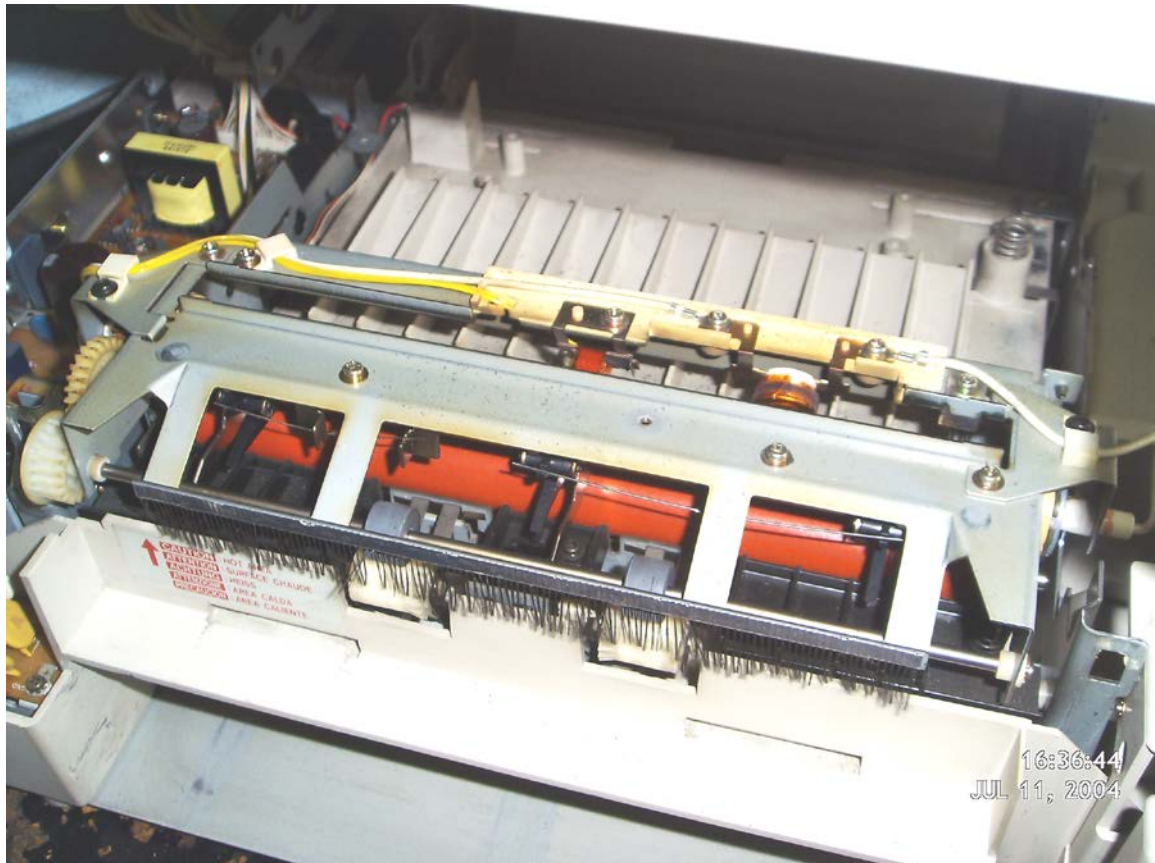
FUSER MODULE

Very often the service technician is called on site to repair a not fusing properly copier. Indeed the copy is not fused and the toner gets stained. This is due to the lower pressure roller coming off its support levers. The bearings A at the end of the roller fall off their supports when a miss feed in the fuser happens. The users pull violently and the roller falls off. The solution is simply to adjust the lower pressure roller bearings back onto their supports. And by the way – it is useful to clean and lubricate the cleaning felt.

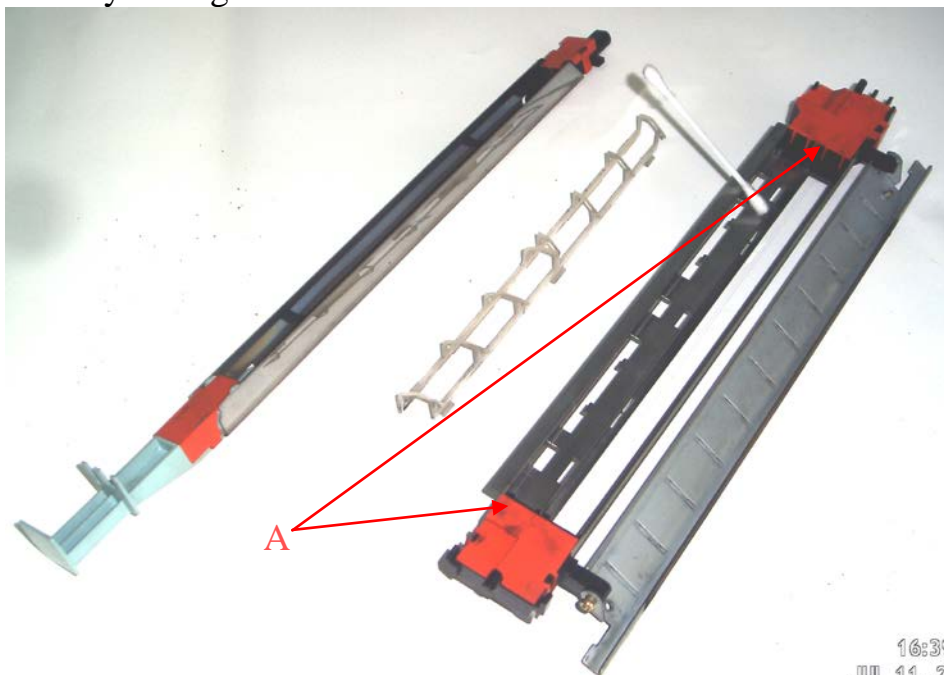
HIGH VOLTAGE RELATED PROBLEMS

Very often these copiers are not cleaned thoroughly. The transfer and separation corotron assembly collect a lot of dust, toner and developer material. As the time passes, these deposits form a conductive layer and a leakage occurs. This phenomenon happens around the corotron terminals A. The result is a faint copy or no image at all. The solution is to replace the terminals or to clean them and pain with nail-varnish. To check if there is still a leakage you can remove the process unit, block the interlock key and power on the copier with the front cover open. Enter the 05 adjustment mode and energize the transfer and separation corotron (codes 39 and 40). You should see the corotron wires glow in violet and if the assembly is operating properly, there wouldn't be arches from the wire to the terminals. Be careful not to touch the assembly during these checks.

Another similar problem occurs when you remove the registration assembly for cleaning. Often the auxiliary high voltage terminal C, located on the assembly gets broken. The effect is irregular and is visible as a faint and foggy copy. The solution is to replace the terminal or to glue it or to attach it with cable tie.

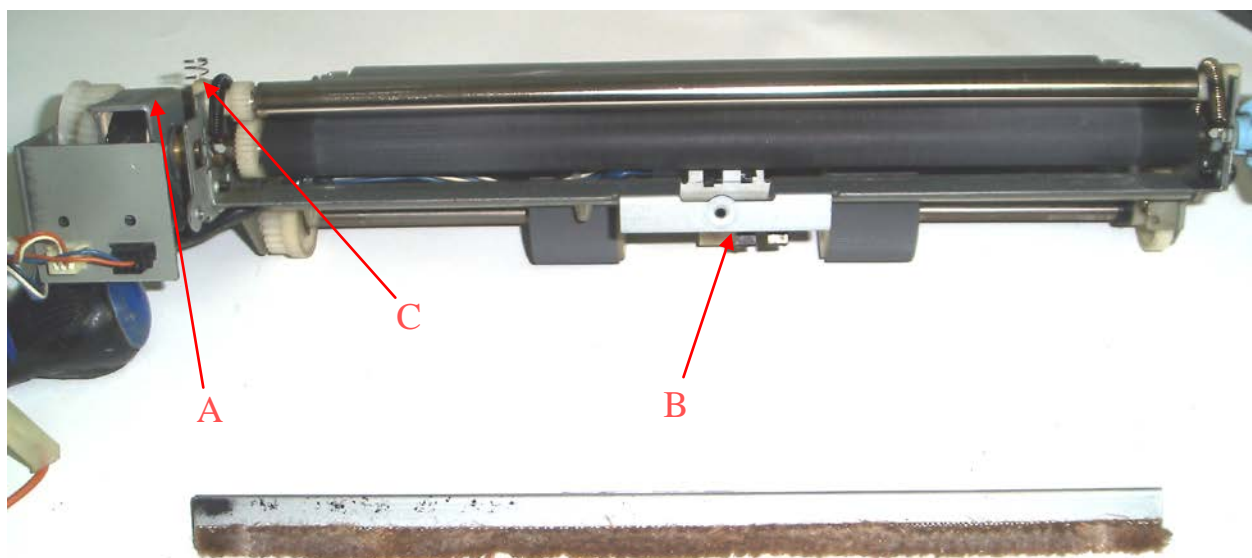
PAPER FEED PROBLEMS

Often after 100 000 or more copies, the copier experiences frequent paper feed problems. Don't hurry to change the feed tires. These are so durable, that even after 400 000 copies they are still like new. The problem is elsewhere. There are two electromagnetic clutches A located in the registration assembly. If the paper doesn't reach the registration rollers, you should clean or replace the feed clutch. You should also clean the one way bearing B, located between the two feed tires. Sometimes it sticks and doesn't transmit the torque from the electromagnetic clutch to the feed tires.

If the paper reaches the registration rollers but becomes rippled and jams there, the cause is still in the feed clutch. The situation is the opposite to the above. This time the clutch fails to disengage when it is turned off and creates resistance, which counteracts to the torque created by the registration clutch.

If the paper reaches the registration roller, but simply fails to proceed you should replace the registration clutch.

In general, if you have doubts about these clutches, you can check them using the service codes 02 (feed clutch) and 03 (aligning roller clutch) in 04 service mode. Turn the main motor (code 1 in 04 service mode). Turn the clutches on and feel them with your fingers, by trying to stop the feed and registration rollers respectively. They should transmit the torque steadily. More important – when you turn them off, they should immediately disengage the drive shafts.

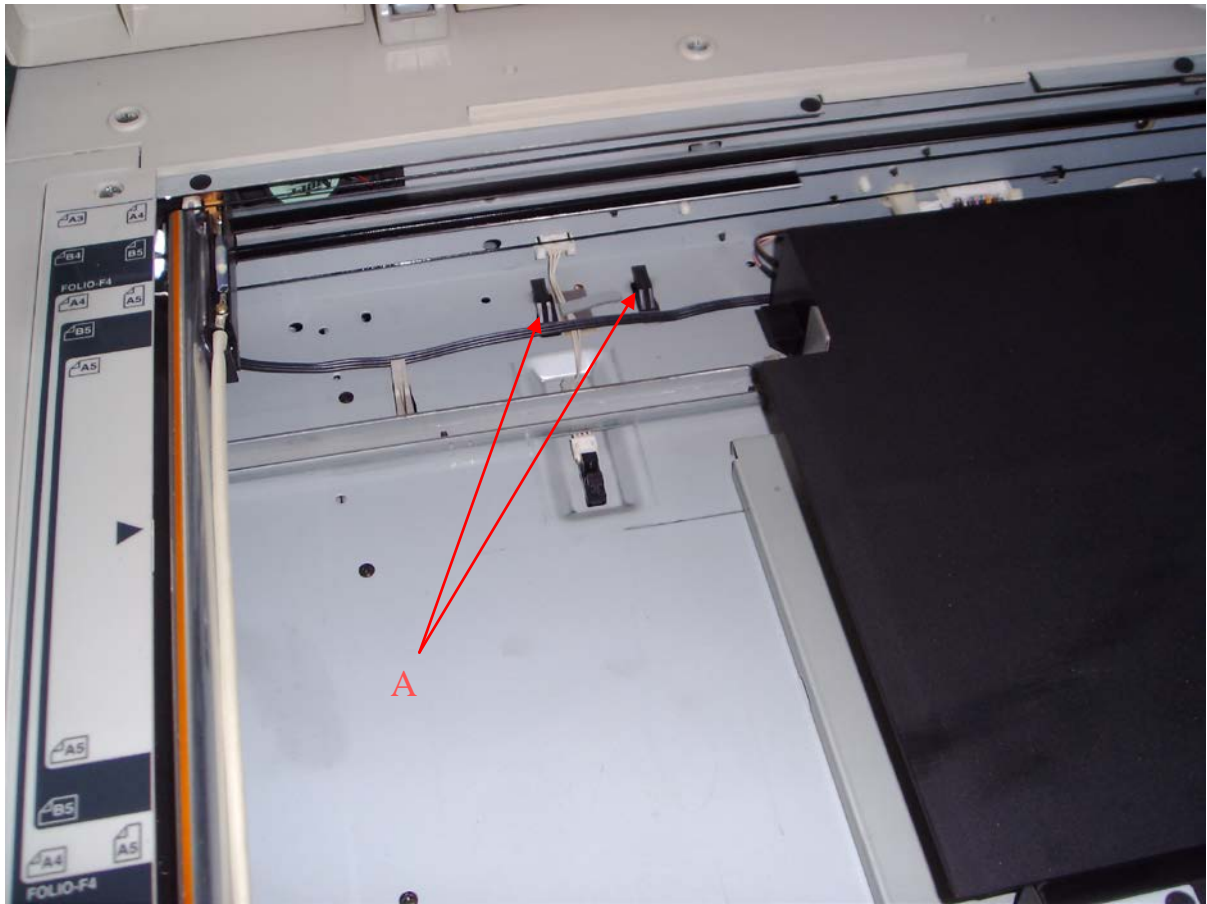
OPTICS MODULE

Actually there isn't anything worrying about this module. The easiest way to look for the most common failure in these machines is through this module. Often clients complain about skewed copies and increased mechanical noise from the machine. This is due to broken teeth of the process unit holder. The holder is attached to the bottom of the optics module via two teeth A that protrude from the bottom. The problem is that these teeth age and break. When this happens the whole holder that supports the process unit starts to move back and forth. The copy is then skewed, but the worst is that the drive train in the main frame of the machine is not properly coupled with the gears of the module. This leads to excessive mechanical noise, wear and finally gears failures. The solution is to remove the holder. Inside it there is a wire harness attached to it by a plastic clip. Remove the clip and enlarge the existing hole so as it matches the hole on the bottom plate of the optics unit (right between the two teeth). Connect the holder and the bottom plate using a long screw and a nut. Thus the holder will never break again.

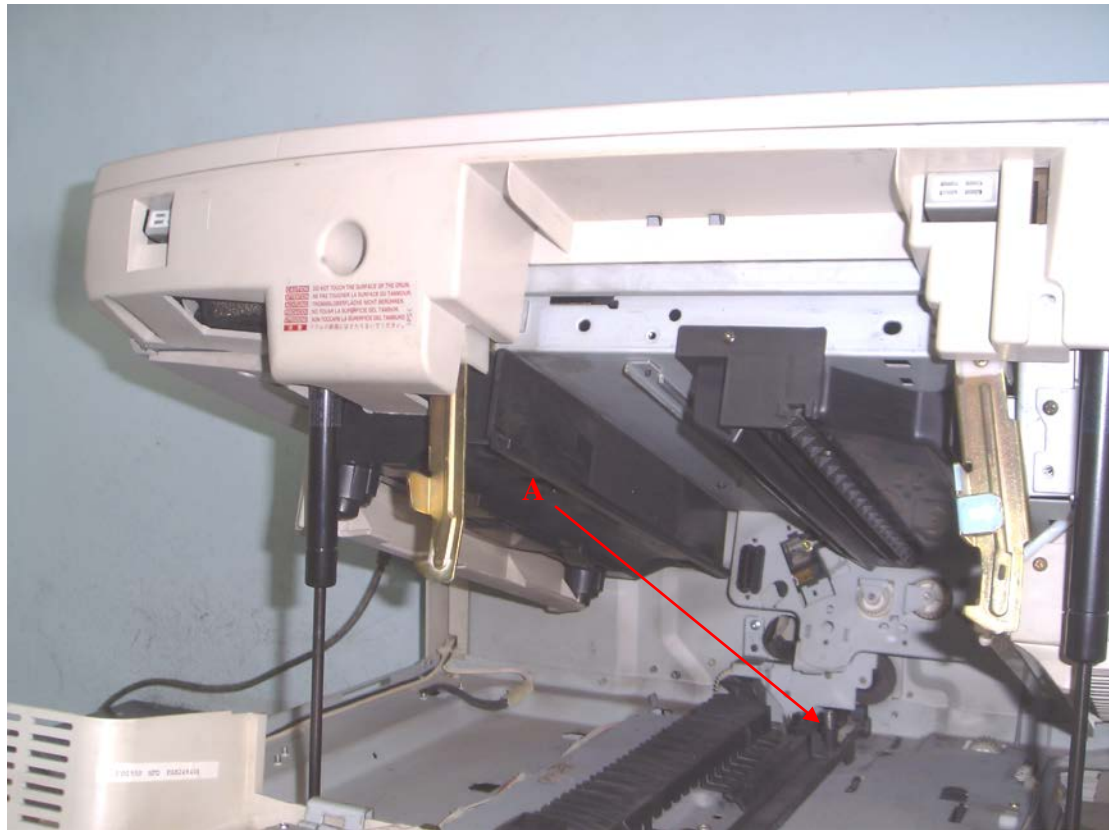
HIGH VOLTAGE RELATED PROBLEMS

Again such problems are present in the model as well. The difference is that there the transfer/separation corotron module is built pretty reliable. The problem comes from the power supply terminal A, located in the rear of the machine, under the corotron assembly. Again paper dust, developer material and toner build up there, forming a conductive layer over time and causing leakage to the metal base of the machine. The result – copies with white patterns all the way of the front and rear edge of the copy, or put in another way – faint copies. The solution is only to replace the terminal. The nail varnish won't work here.

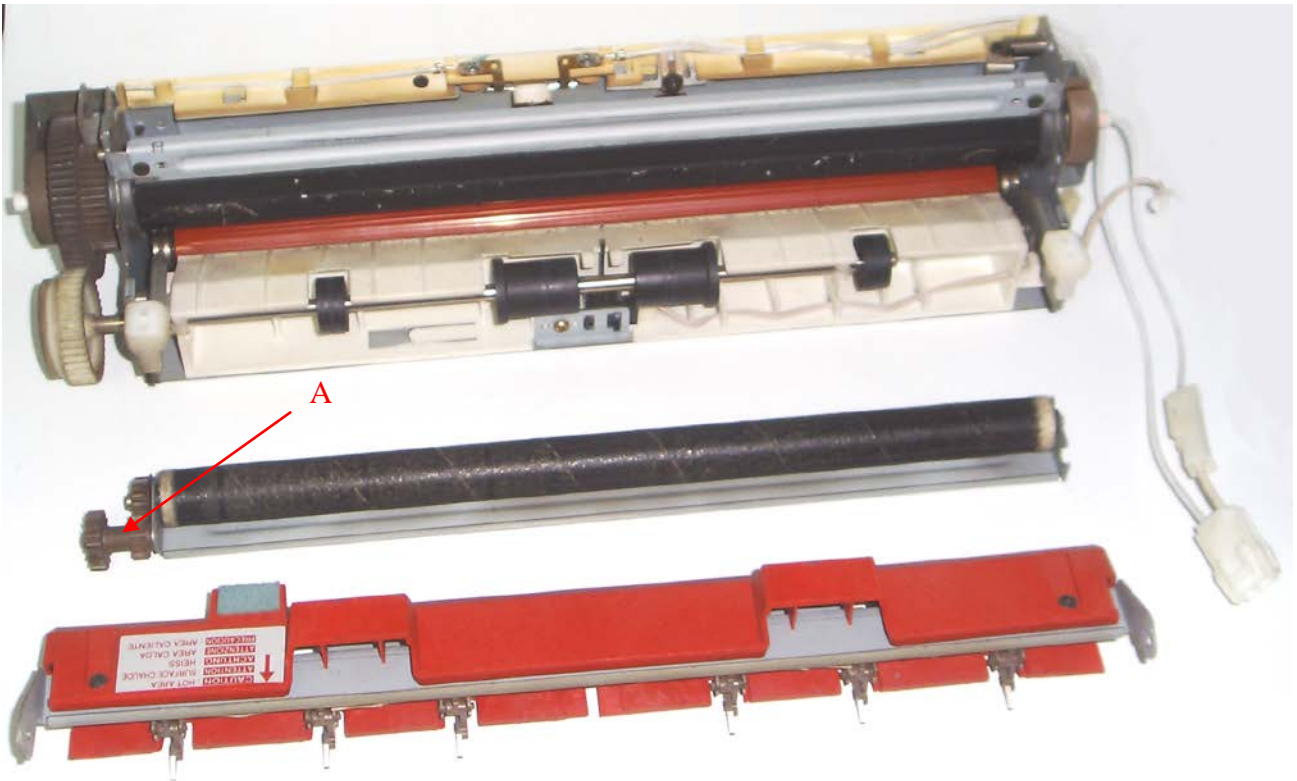
FUSER UNIT

This is quite a durable module, given proper maintenance over time. However there is a gear A, which transmits the rotation of the heat roller to the cleaning felt roller. The gear is made from soft and quite rapidly wearing plastic compound. If you hear a sharp mechanical clatter from the module, the reason would probably be the gear is worn. Apparently you should replace it, but if, during periodical maintenance, you brush the teeth of the gear from the accumulated dust and clean with alcohol the gear's axle, it would last much longer. NOTE: never lubricate the teeth of this gear. This will only make it wear faster.

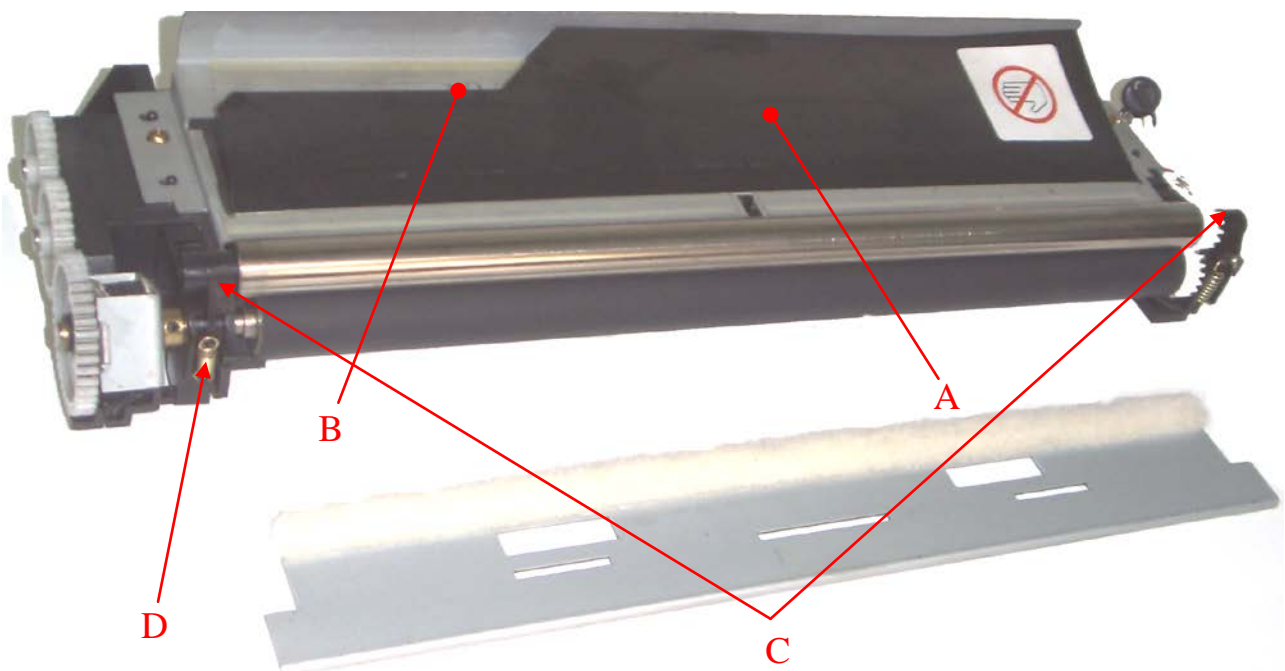
REGISTRATION MODULE

This is quite a problematic module. First of all often clients complain about paper jams in this module. The first thing is to ask them to look under the black mylar sheet A, on top of the module. Under this sheet there are several clear plastic guides B for the copy sheet. If there is an object there blocking the paper path you should remove it. Another possibility is that some of the guides are displaced and set above the metal plate instead of under it.

Further the reason for skewed copies can be in this module. At both end of the registration roller, there are two levers C, which press against each other the upper and lower registration rollers. The force to press them comes from two very stiff coil springs D. Stiff the springs may be, but the hooks on the upper levers are not. They break and the rollers are not creating enough friction to transport evenly and align the coming sheets of paper. One solution is to “fix” the problem by boring holes in the upper levers and hook the springs there. I wouldn’t recommend this. In short terms this solution works, but as you hook the springs on higher position you also over extend them and in long terms they loosen and the initial skew problem reoccur. The right solution is to simply change the broken upper levers. NOTE: Be careful when you attach the springs to the new levers – they are just as fragile as the old ones. Toshiba never learned its lesson with these parts.

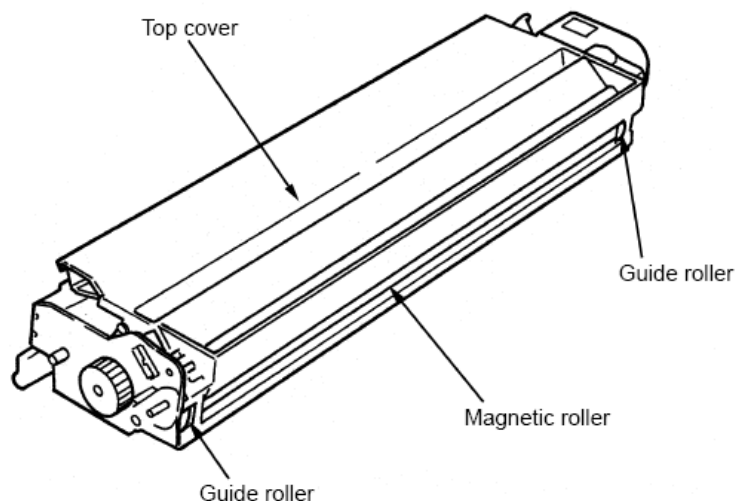
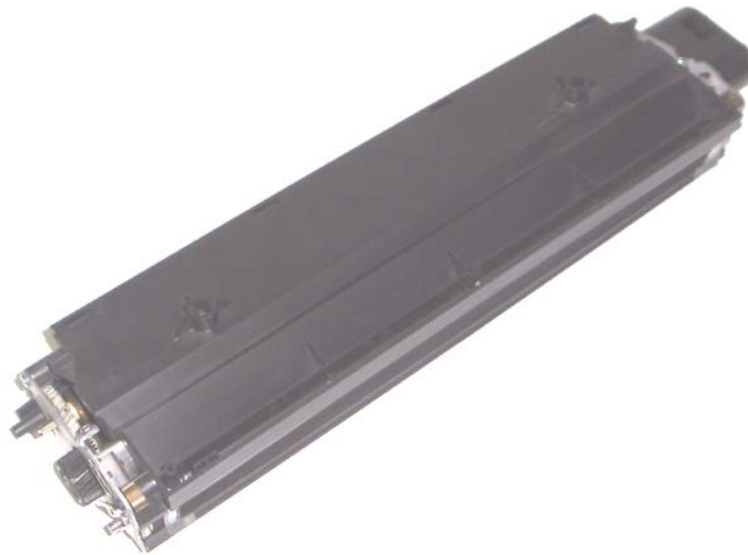
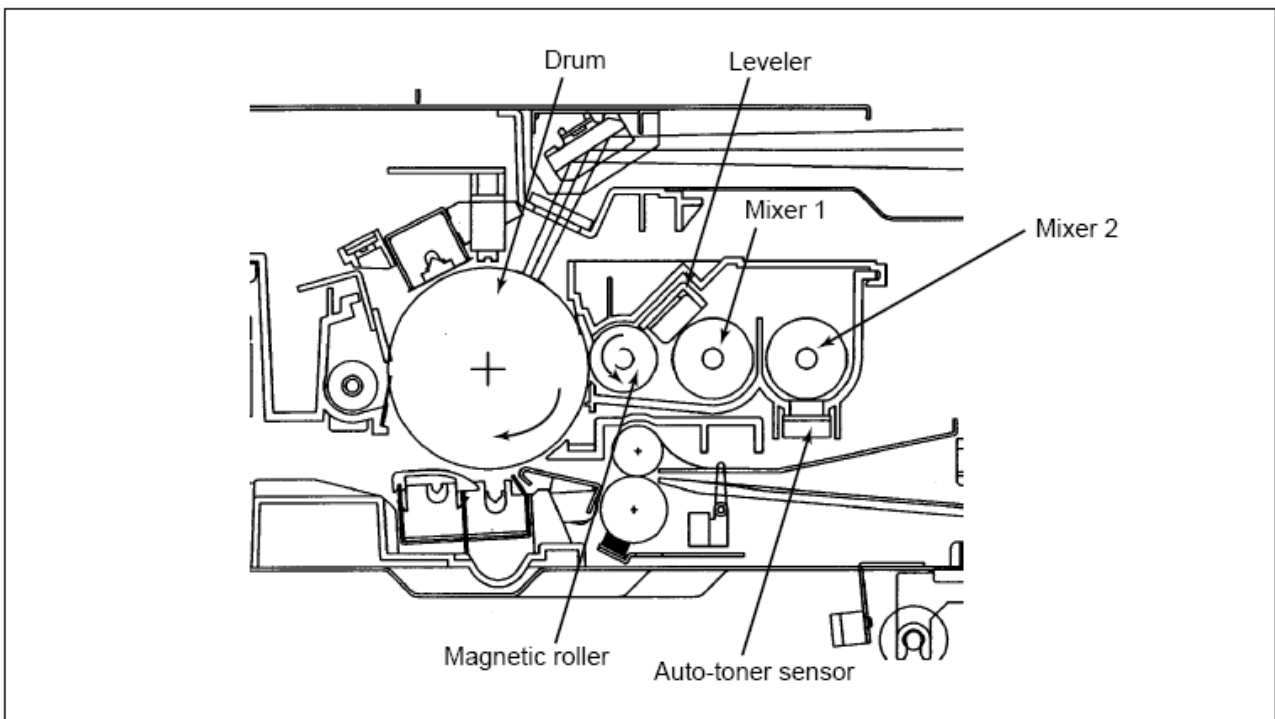
DEVELOPER MODULE

Finally we come to the notorious even dreadful module of this machine. Most service repairs are done on this module. Almost every part of it is prone to failure. We will start with the construction of the module, shown on the figure. It is important to note that the described bellow problem occur after 200 000 or 300 000 and more copies. Even if you carefully inspect this module every time you make periodical maintenance it will still cause you troubles in future. However it is useful always to check the mechanical operation of the module by rotating the module’s input gear in the direction noted on the developer roller axel fixing plate. The gear should rotate relatively smoothly without too much torque required.

After about 400 to 500 thousand copies this roller may lock, causing all sorts of gear failure all the way to the main gear drive in the main frame of the machine. The reason for that is in the construction of the roller. It consists of a aluminum sleeve, mounted via bronze bearing to a central axle. Inside the sleeve, the axle consists of a metal rod and segments of long magnets glued to it in a circular pattern. Over time some of these magnets unglue them selves and fall inside the sleeve, acting like edges and locking the relative movement of the sleeve to the still axle. The only working solution is to change the developer roller. This leads us to the second problem:

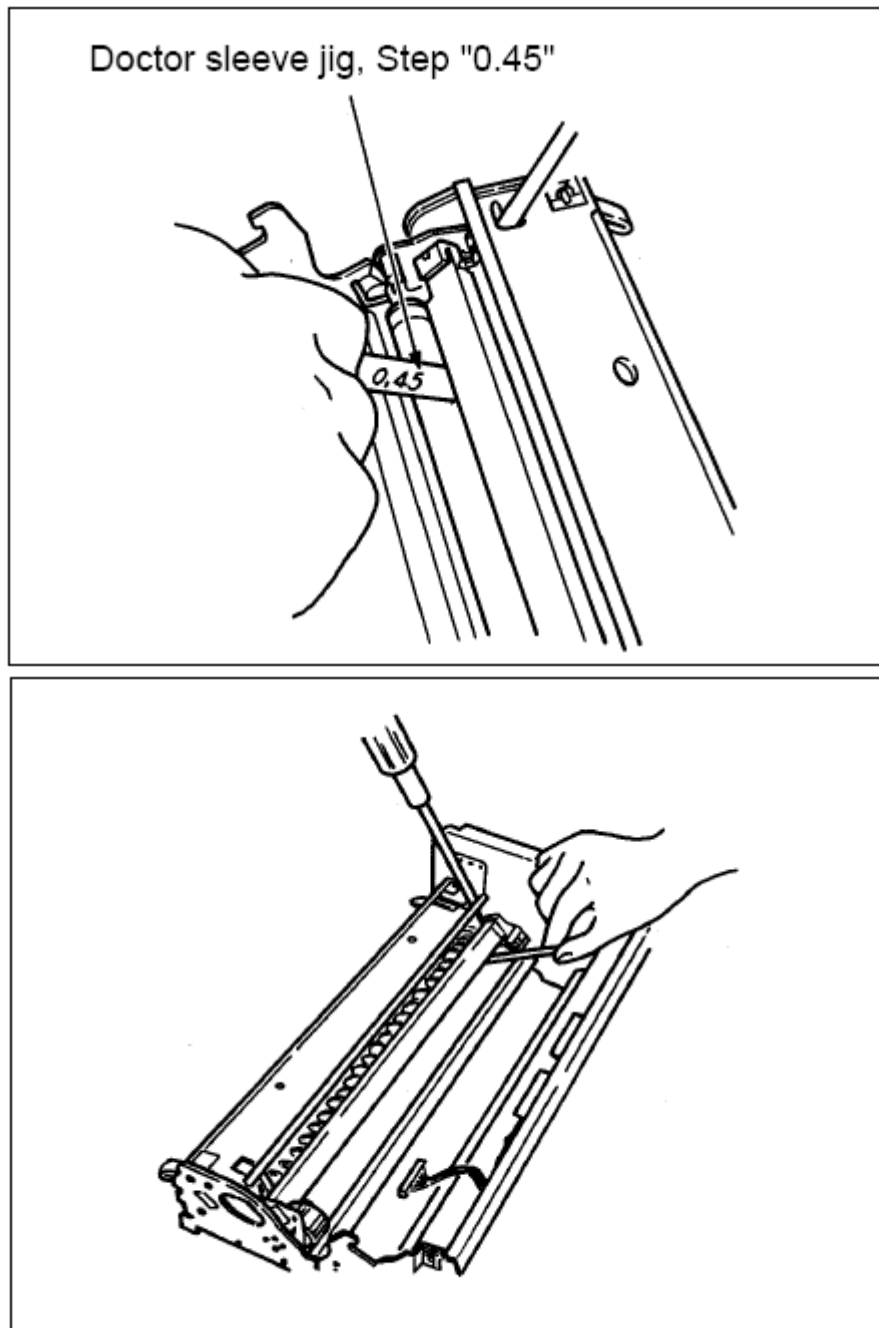
Leveler

Many technicians overlook the importance of proper setting of the thickness of the developer layer on the magnetic roller. In Toshiba copiers it is critical!!!! The thickness of the layer is specific for each model. For 1550 it is 0.45mm. The thickness is achieved by measuring the gap between the leveler and the magnetic roller by thickness plates:

The reason for that strict tolerance is that if you increase the gap too much, the developer brush will reach the OPC drum surface and polish it, destroying the photo sensitive layer. Also the increased thickness will lead to increase in the torque required to drive the module. This in turn leads to excessive wear in the drive gears

and tooth belts. The opposite case – decreasing the gap too much may lead to failure to form developer brush on the surface of the magnetic roller at all.

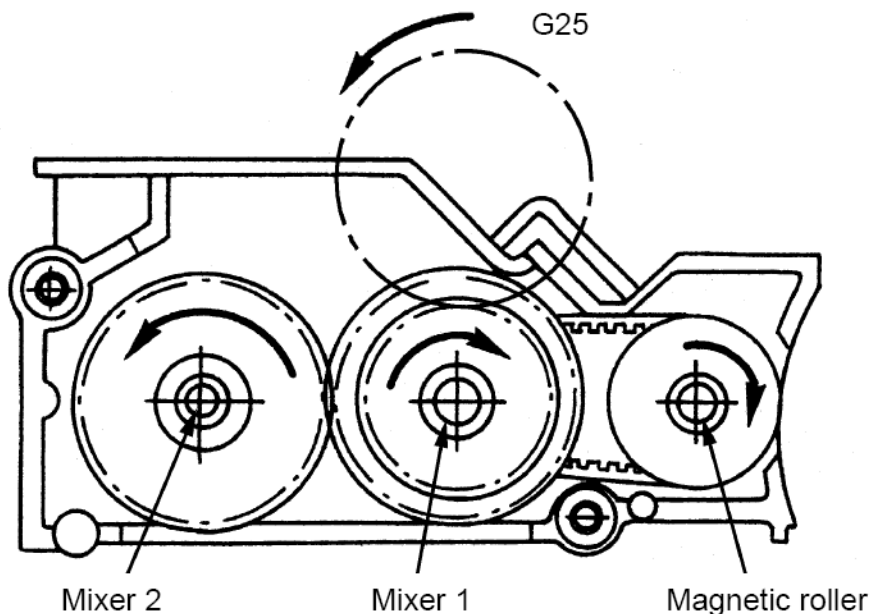
Another reason for increased torque needed to drive the module is the developer mixers. Their role is to stir the developer material in the developer container. They receive torque through the drive gears of the module. However part of them must be outside the module in order to receive movement and the other part must be inside to actually stir the developer. In order to achieve this seals must be used. They are mounted in the side walls of the developer container. After the seals there are bronze bearings on each side of the mixers. After 300 000 or so copies these seals start to leak and the problems begin. If you do not replace them immediately, the space between the seals and the bronze bearings will fill with developer material. The bearings are pushed away and press the mixers drive gears into the side metal walls of the module, causing it to block. Furthermore the developer material acts like a grinder and can decrease the diameter of the mixers shafts, which are in contact with the bearings. Once this happens the mixers are no longer fixed and the drive belt of the magnetic roller starts to loose grip.

In conclusion all of the drive gears and belts in the module are endangered of excessive wear and failure. The drive train is shown o the figure bellow:

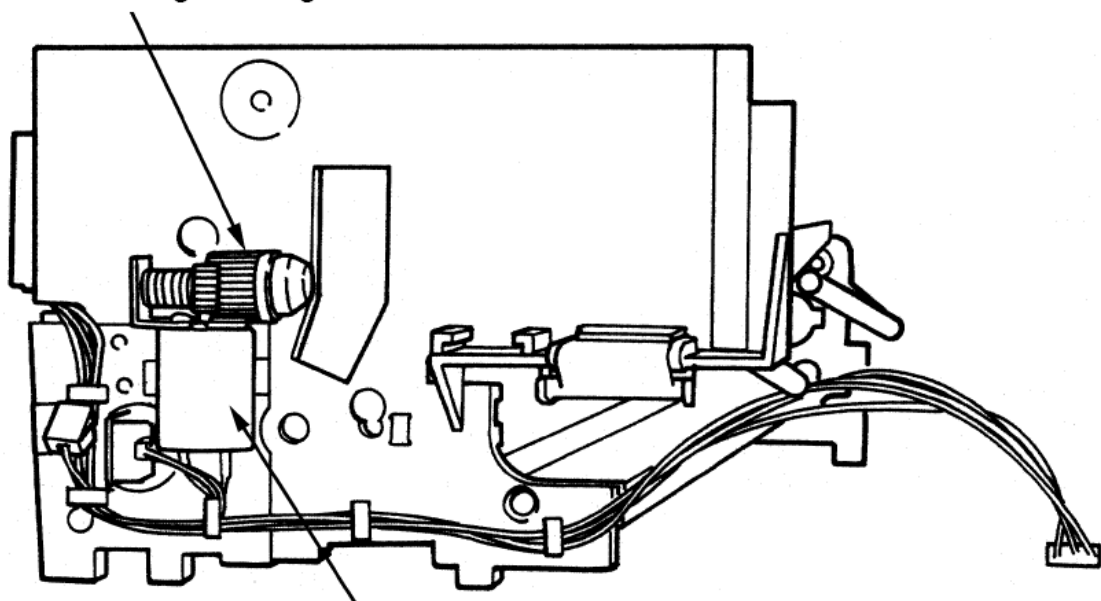
Low toner concentration in the developer module

The most exotic problem I have experienced with this model is the faint copy produced by the machine, which I determined was caused by a very low toner concentration in the developer module. Sometimes due to power surges, copiers tend to forget some of their critical adjustment values such as the auto toner sensor output signal level. Usually performing the auto toner sensor adjustment solves the problem and the “add toner” symbol disappears. However sometimes there is toner in the toner cartridge. The auto toner adjustment is made, the sensor itself is working properly and again after several hundred copies the copier still shows the add toner symbol. Upon inspection the developer material is almost stripped off toner. The solution to this phenomenon turned out to be a faulty toner cartridge. The drive shaft through which toner is supplied to the developer unit was blocked and the toner supply motor couldn't rotate it. At first glimpse, this was not so obvious, because the toner motor has a preventive mechanism for just such occasions – drive gear G26 has a failsafe spring into itself, which disconnects the toner cartridge from the toner motor without causing the mechanism to rattle. The construction of the supply mechanism is shown on the figure:

An the conclusion is that your clients should always check the proper operation of each new toner cartridge before installing it, by turning its output shaft by hand.
