TOSHIBA THE 60TH SERIES ANALOG COPIERS – A FINAL ANALYSIS OR WHICH ARE THE MOST COMMON AND MIND SCRATCHING PROBLEMS IN THESE MACHINES PART 2.

This is the final article about Toshiba's 60th series analog copiers. In the article you will find the most common problems, found in the models 2060, 3560 and 4560, as well as in their options – duplexing unit, sorters and automatic document feeders.

TROUBLESHOOTING THE 2060 3560 AND 4560 MODELS

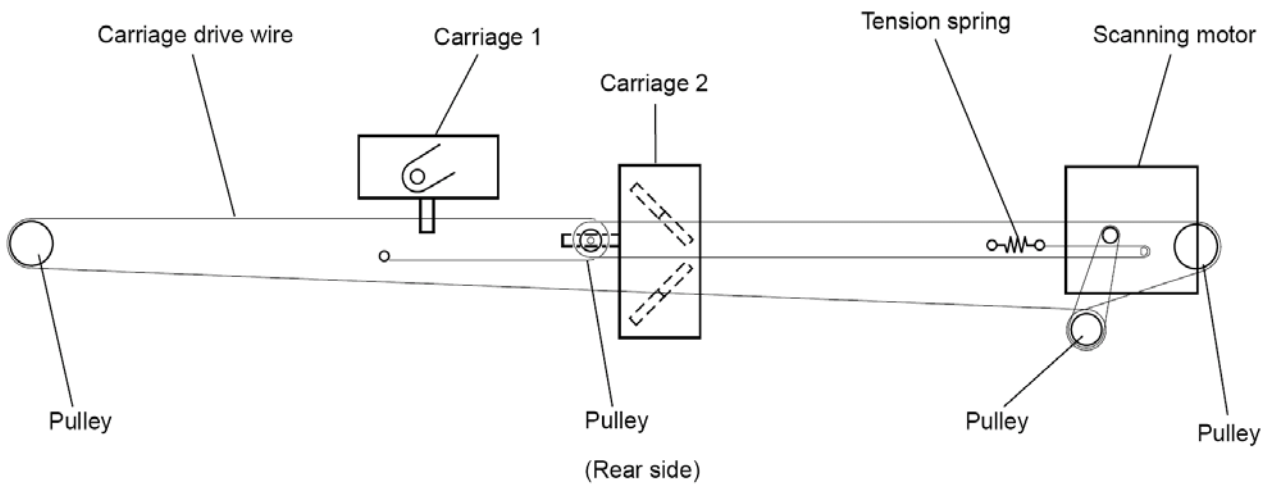
Installation of Carriage Drive Wire

The biggest issue here is to have to change the optics carriages drive wire, but it happens very rarely:

When the carriage drive wire is replaced, attach the new wire as shown:

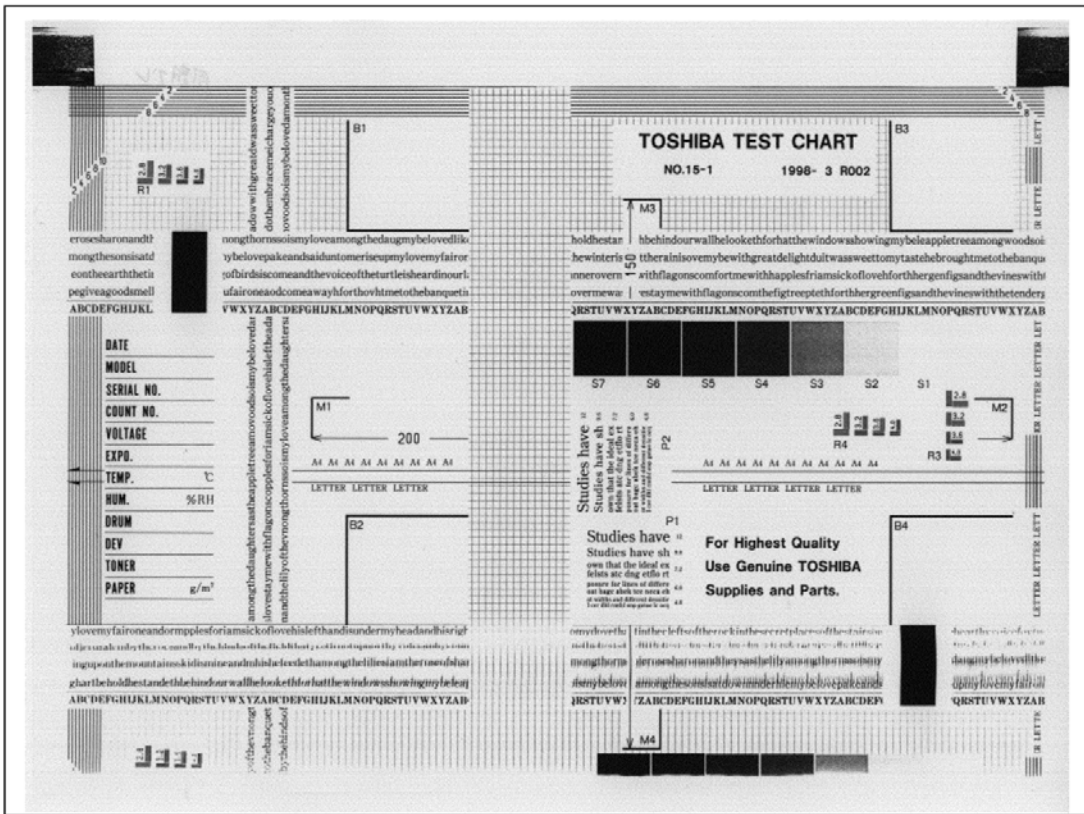
Another issue in the optics module is to have uneven focused strips on a specific area on the copy, shown on the figure below:

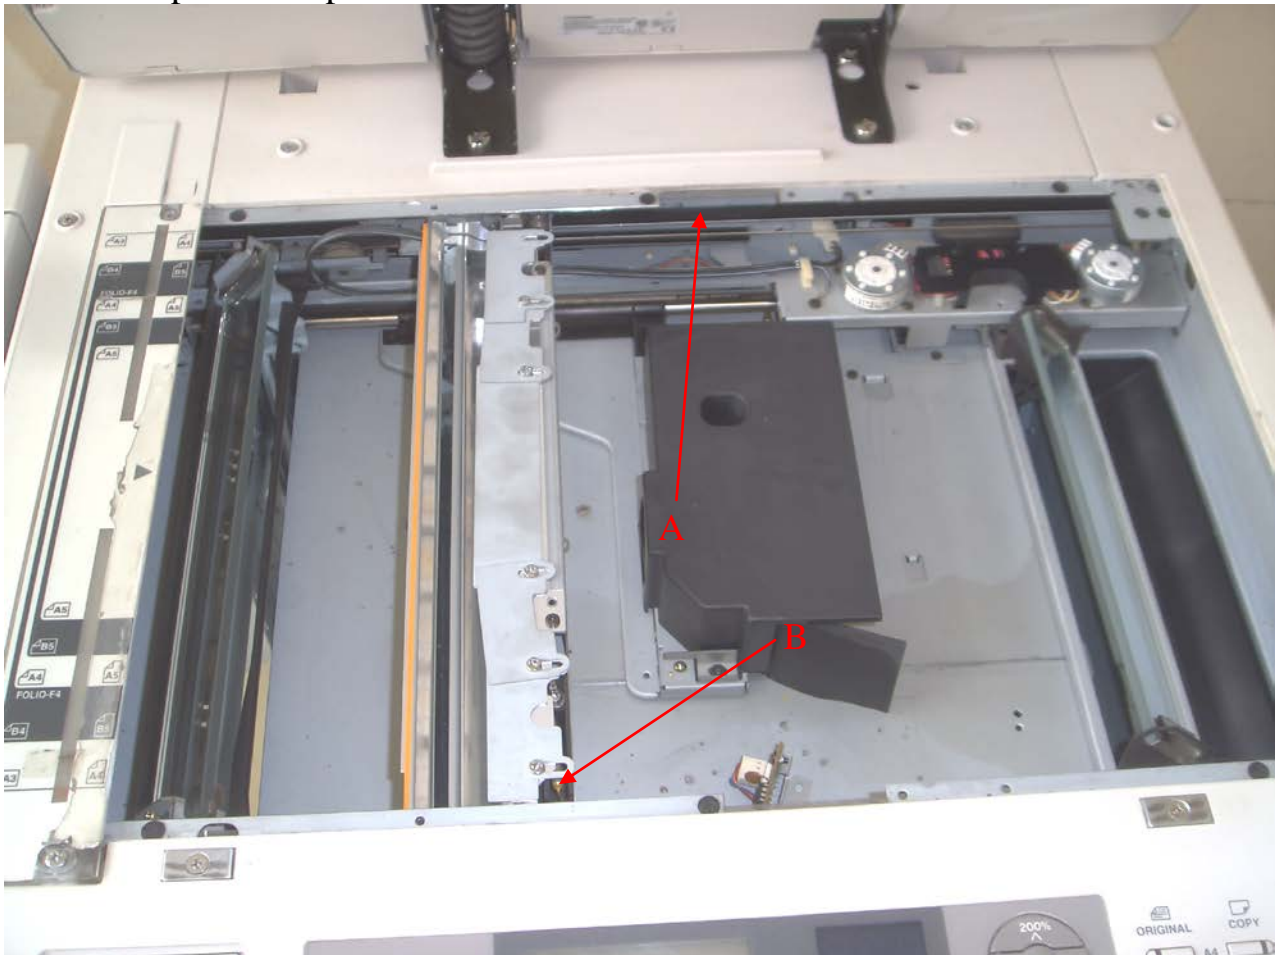
This is due to bumps forming in the guides A of the carriages, when the low friction strips start to peel off in some areas:

Another problem in the optics module is when the machine blows again and again the thermo fuse on the exposure halogen lamp (see B on the figure above). The problem is the cooling optics fan, found at the back of the machine.

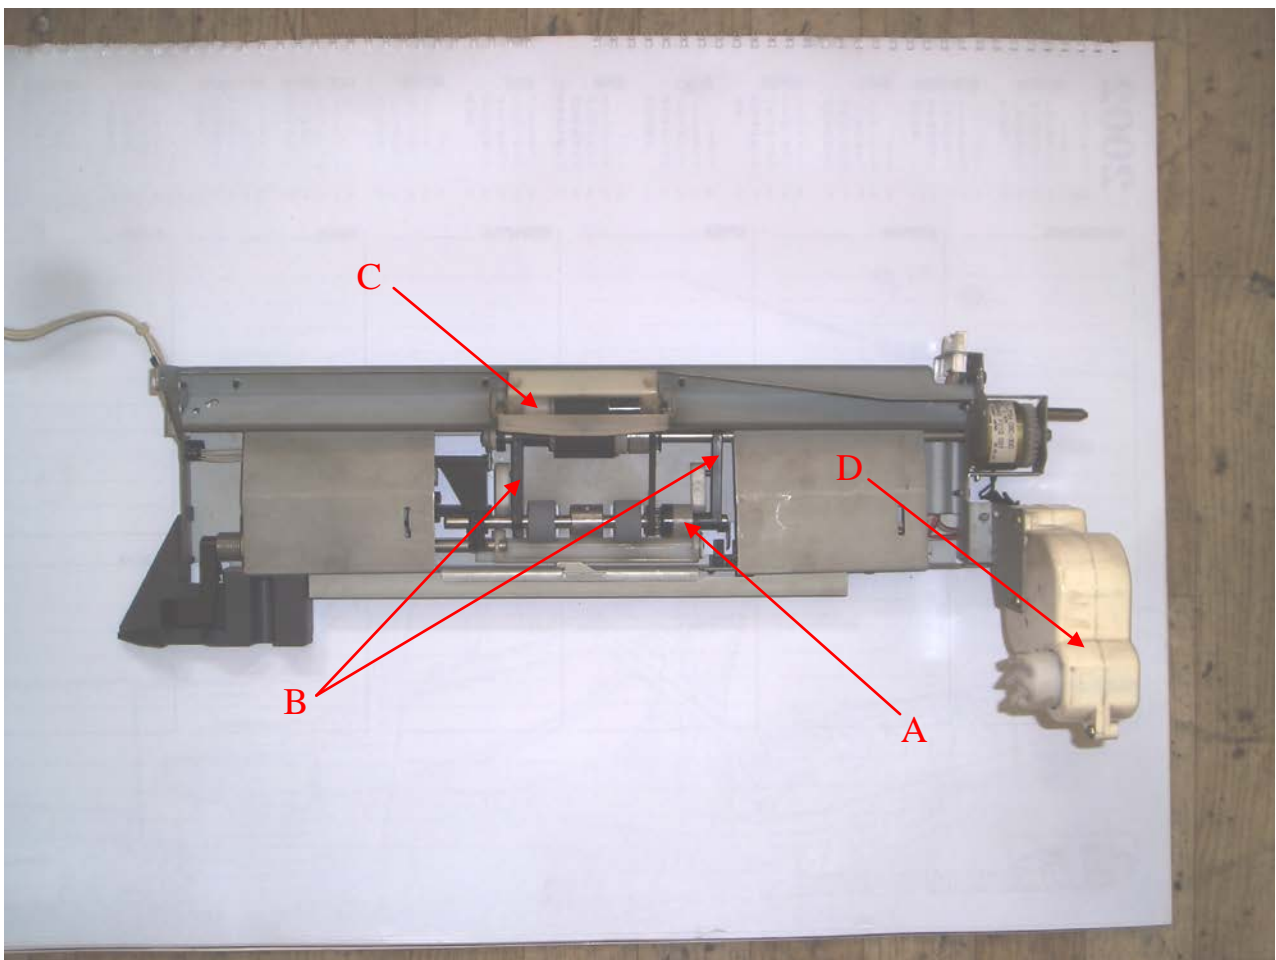
Normally the module works very reliably. However there are some problems over the years of exploitation. Sometimes the copier wouldn't pick up paper from the paper trays, built in the machine, even though the rollers are replaced. This is caused by the one way clutch A mounted on the pick up rollers. It becomes dirty and doesn't transmit torque to the pick up rollers. The solution is to remove it and spray it with isopropyl alcohol and clean it with cotton swabs.

The other cause may be the pick up roller engaging levers B snap of f its places. The solution is to snap the levers in place.

Yet another reason may be uneven wear of the separation roller. The pick up rollers take the paper, but it stops at the feed/separation rollers. This is caused by contamination of the separation spring clutch. The separation roller fails to rotate following the fed paper and wears only in a strip. The solution is to replace the roller and to lubricate the clutch C :

Sometimes the copier says that a certain paper tray is empty, even though it is not. This is caused by failure (broken teeth) in some of the gears in the reduction unit D on the figure above.

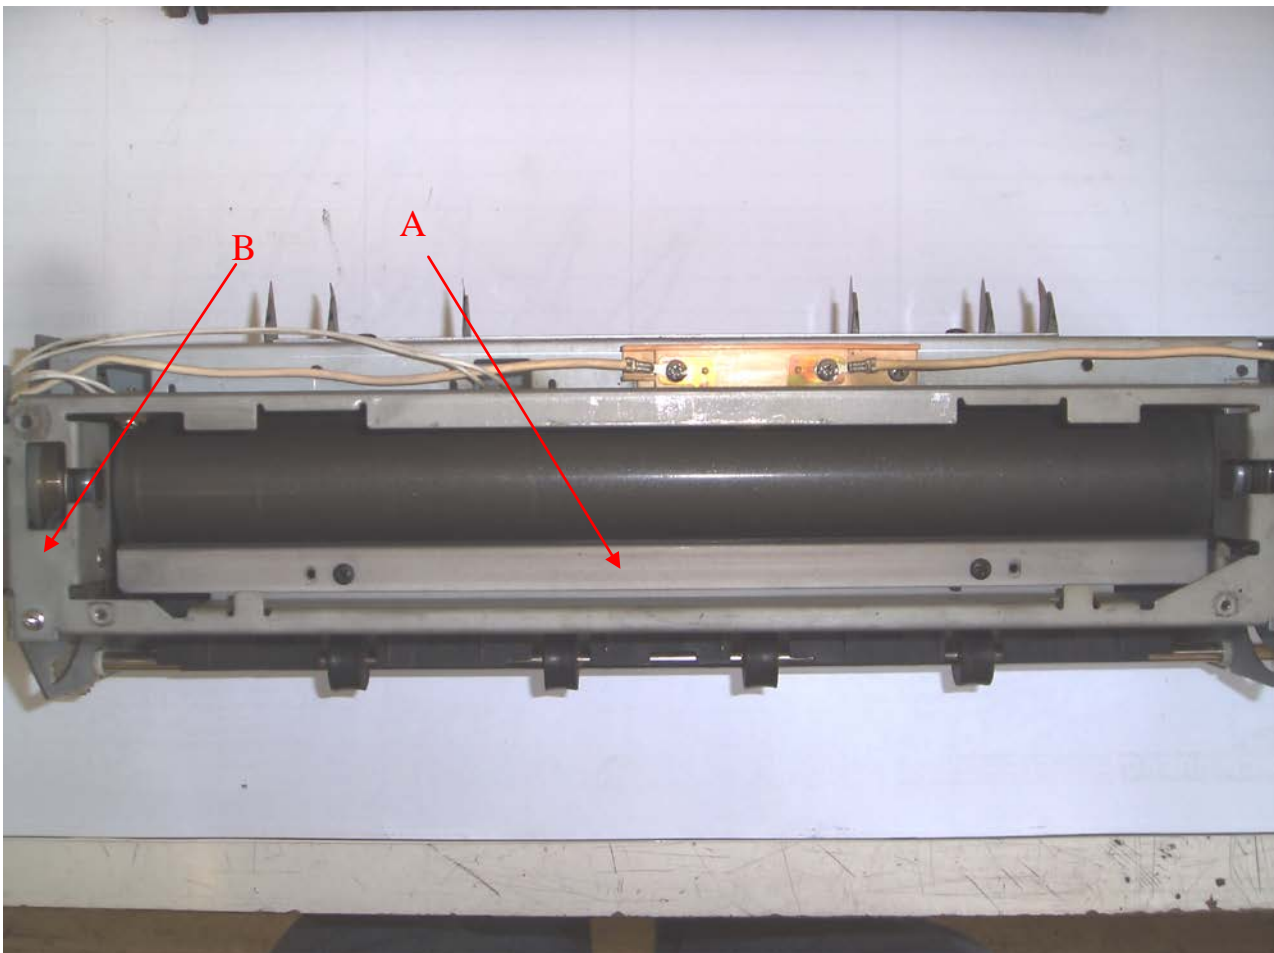
This is a relatively reliable module, given proper and regular maintenance, as described in detail in previous articles. However there are some problems with this module. Often, due to poor cleaning, performed on the cleaning fuser blade A, it flips off and causes damage to the upper fuser rollers and even worse – to the drive gears of the module. The solution – simply be patient and clean entirely all the components in the fuser module.

Another problem is the drive gear B which drives the silicone roller. It is made of weak plastic material and wears off very quickly. It also wears quickly if you apply silicone grease on its teeth. It is important to clean with alcohol the opening for the shaft in the gear:

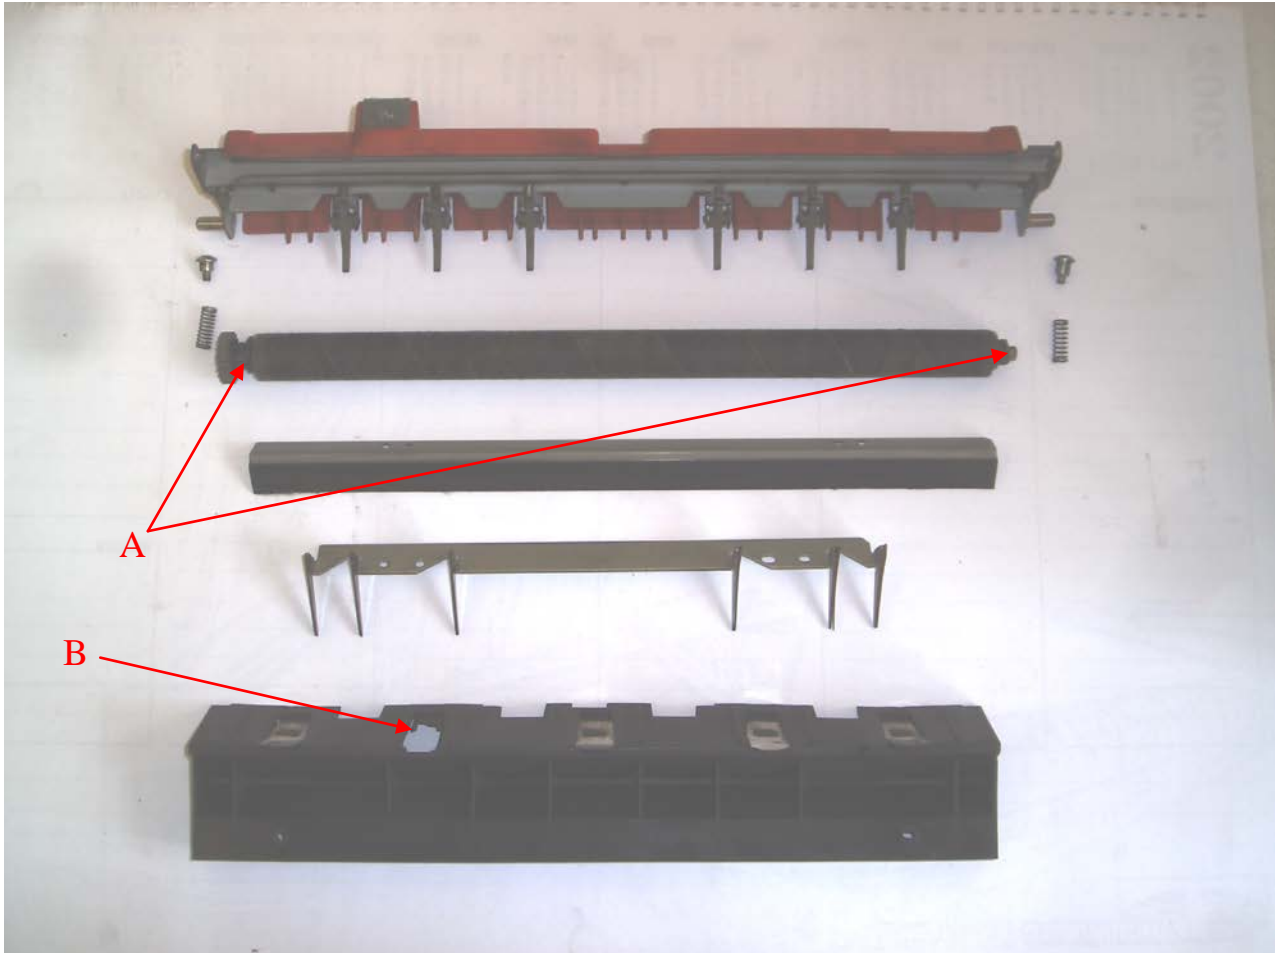
Sometimes when removing the bushings A of the silicone rollers, one can break the guides for the loading springs of the roller.

Sometimes the upper roller fingers accumulate dirt, which causes some of them to first move back from the roller, causing paper jams. When the operator removes

the jammed paper he doesn't notice the finger and after the next copy it is forced by the paper to dig in the upper fuser roller causing severe damage.

The lower fuser roller suffers the same condition. The difference is that here the finger first digs into the lower rubber roller and then in breaks off its mounting position causing damage both to the roller and the mounting plate, made of plastic B:

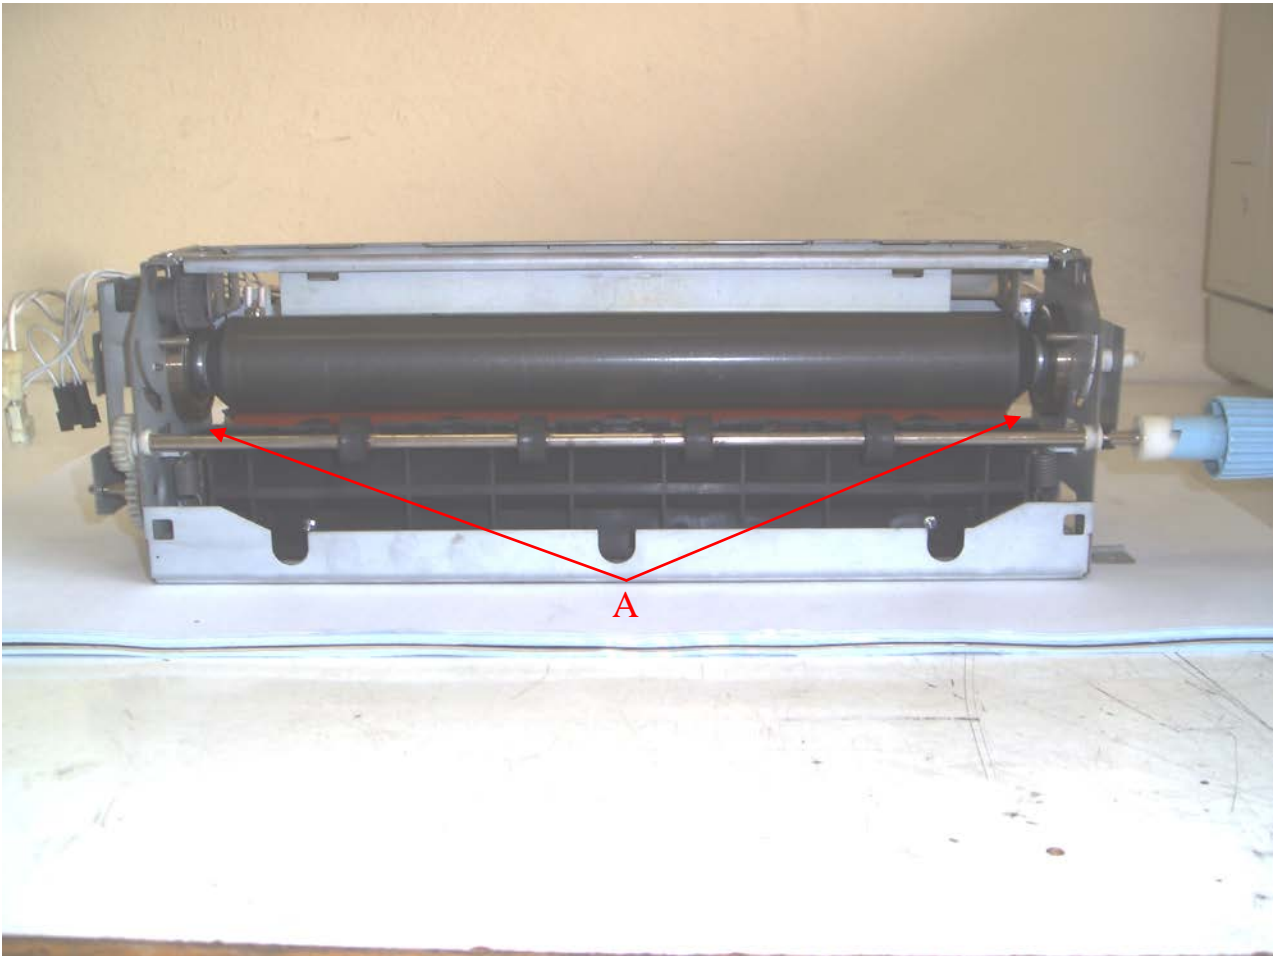
Finally after many thousands of copies, the copier begins to produce poorly fused copies. This is caused not by fatigue of the loading springs that force together the two rollers but by wear of the shafts of the lower fusing roller. It is suspended on two roller bearings A that block and cause the lower fuser roller's shafts to rotate inside the inner bearing's collars causing excessive friction and wear. As a result the shafts diameter decreases and the nip between the upper and lower roller reduces. That's how you get poorly fused copies:

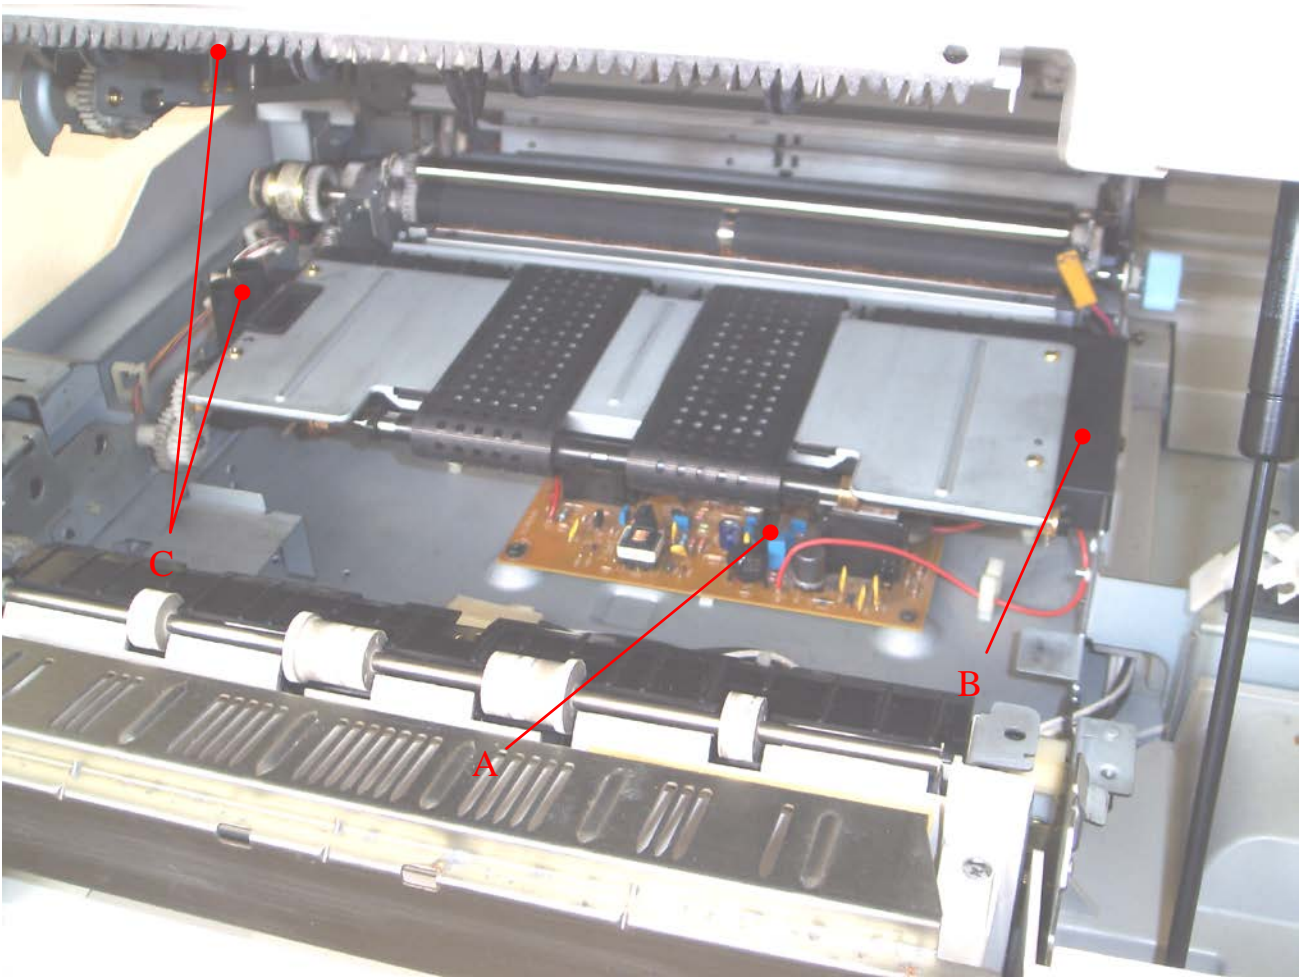
Very often the copier behaves strangely, paper jams are frequent and the inside of the copier seems to be all right. Well, the problem is that there is a developer material spilt over the high voltage boards A, beneath the transport belt, or over the separation/transfer corotron terminals B. The solution is to clean under the belts, but if you don't find the cause for the spill in the developer module, it will leak again.

Another hidden defect occurs when the copier's shocks, that keep its top half up when opened, fail. Then the upper half drops down heavily when opened. After several drops the copier starts to produce blank copies or copies with background. What happens is, the terminals C for the main charger and grid break off their places and don't conduct the high voltage to the charger. The solution is to glue the terminals to the sides of the copier and warn the operator to be careful not to drop the upper half of the copier heavily.

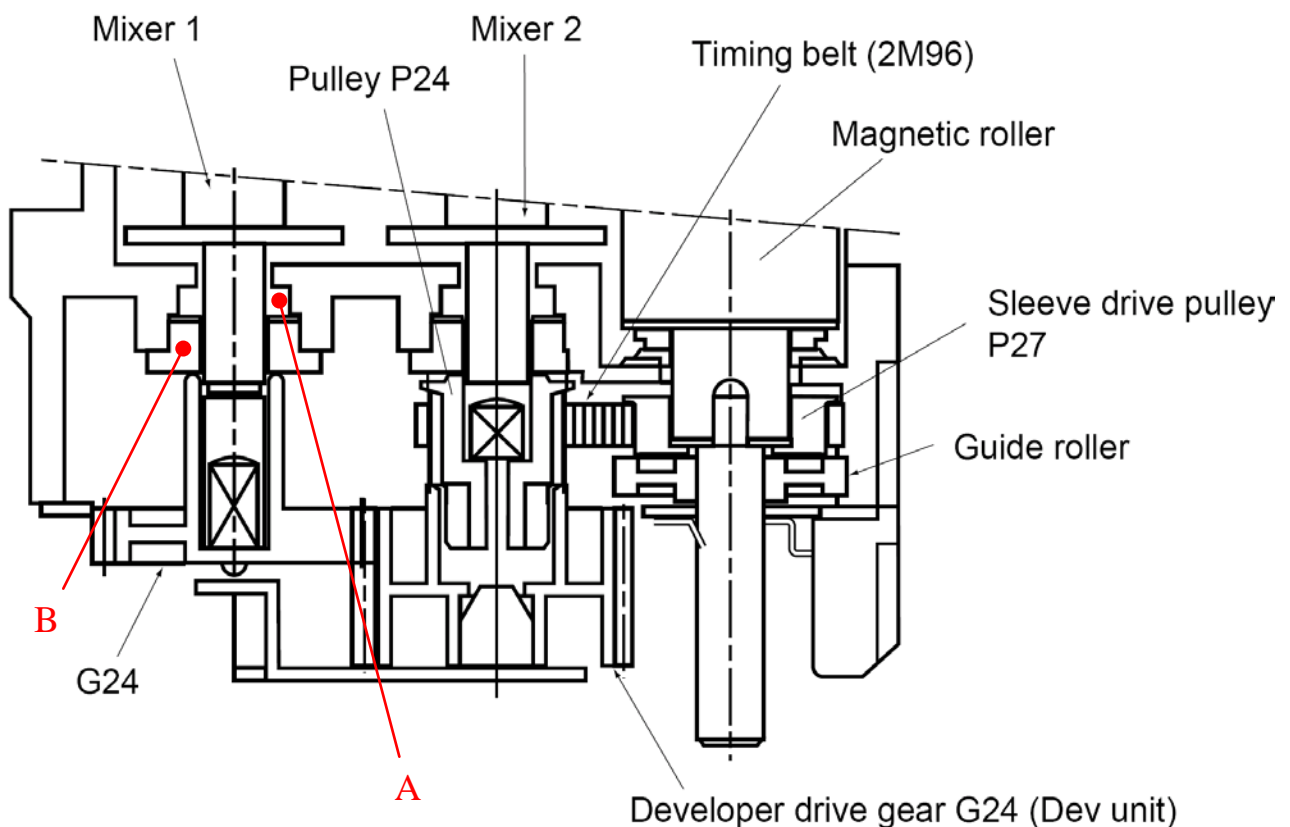
Another common problem is spillage of developer material from the mixers shafts 1 and 2 at the rear end of the module. The shafts rotate inside the developer hopper, but receive torque through the gears at the rear end. The shafts go through the walls of the hopper and are secured by seals A. If these seals leak, the developer damages the bronze bushings B and the driving teeth of the module. This happens always at the rear end seals. So it is important to check these seals, every time you perform a periodical maintenance of the module.

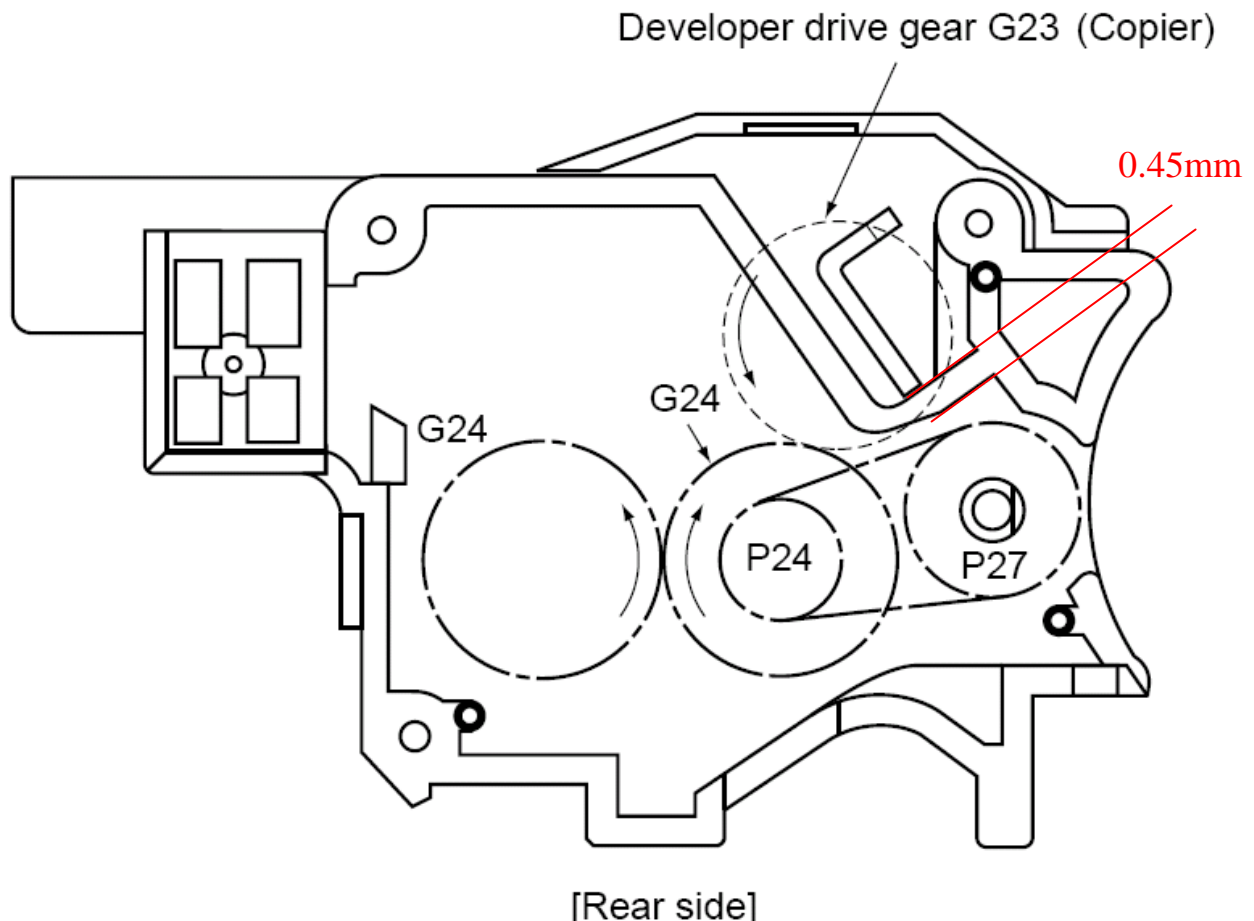
Common for all Toshiba 60th series developer unit is the use of adjustable doctor blade. The developer layer thickness is adjusted by rotating two screws at the ends of the doctor blade, using a gauge. If the thickness of the layer is over 0.45mm the developer brush reaches the OPC drum surface and polishes it. This makes the OPC drum useless. The rotation of the module is very difficult and the gears may break. If the thickness is below 0.45mm the developer material wouldn't cover entirely the magnetic roller and the copies will have "fluffy clouds" effect.

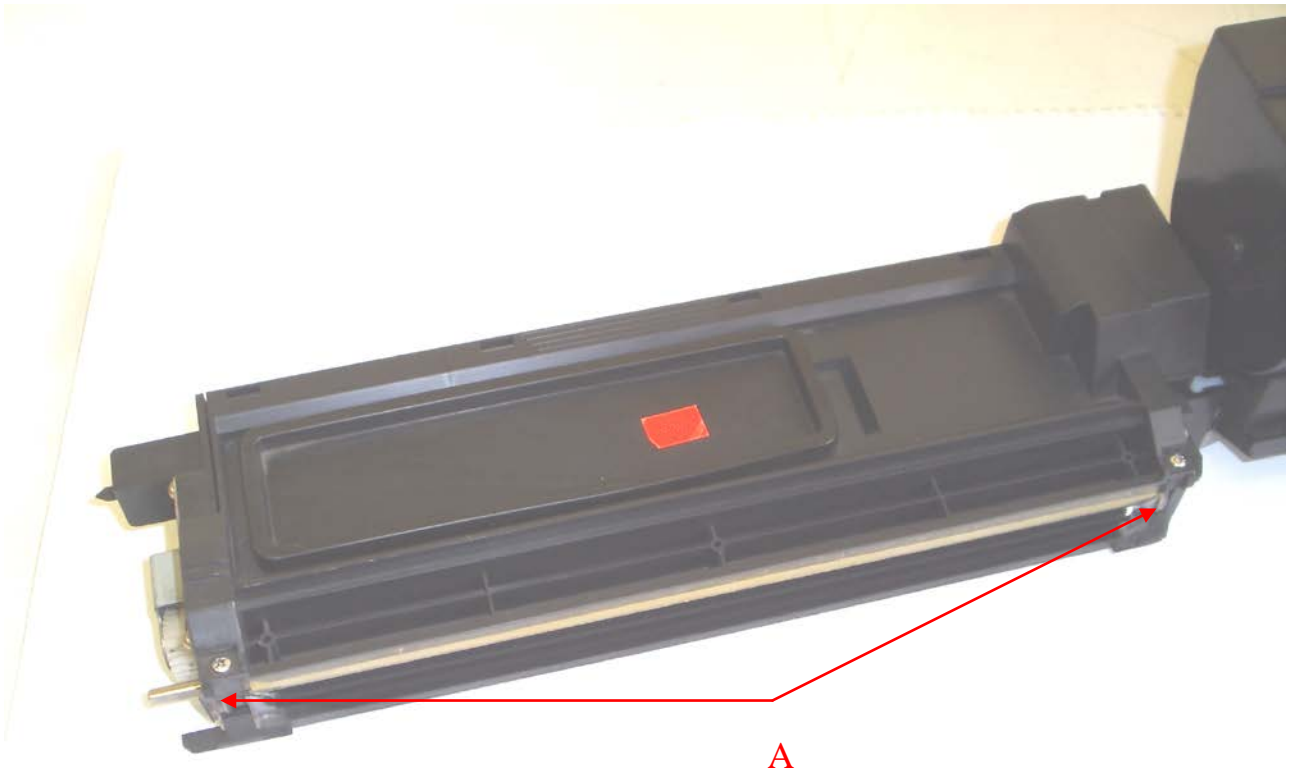
Finally – often the service technician encounters polished OPC drums that are not good for copying and he wonders why, when everything seems normal. The developer gap is 0.45mm and still the drum is damaged. Well, this is one of the biggest flaws of all developer modules from the 60th series. The developer unit is kept apart from the OPC drum unit at a preset distance, using two guide rollers A. They are mounted on each end of the developer roller and rotate onto the OPC drum's surface. Their inner and outer diameter determines the correct distance between the developer brush and the OPC surface. It is very important to check the free rotation of the guide rollers as well as their diameter and replace them if necessary.

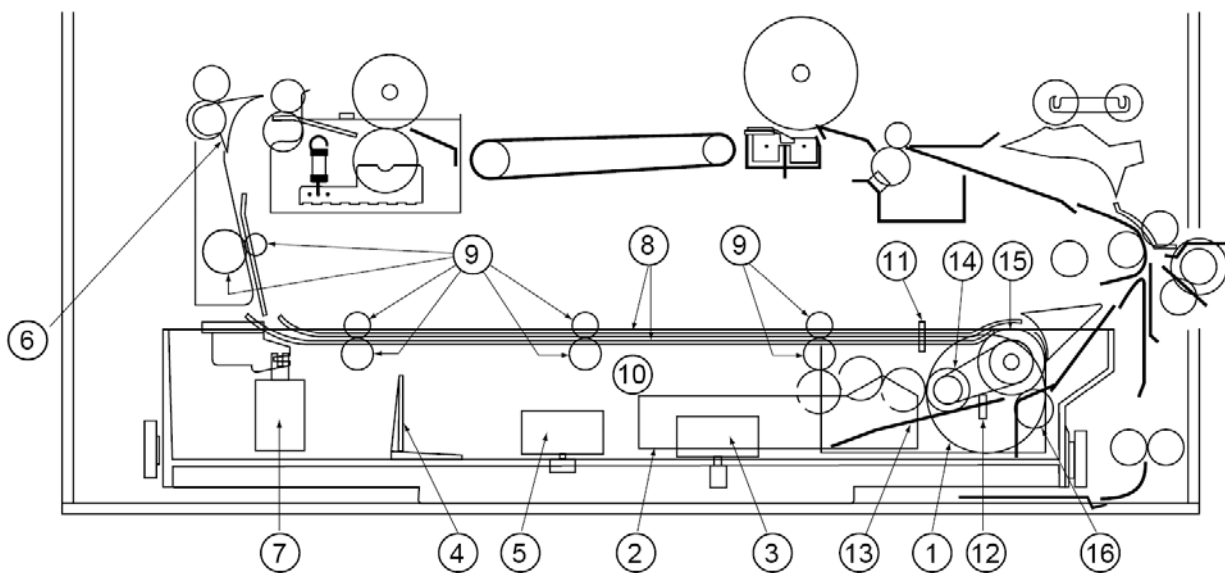
The construction of the module is shown on the figure bellow. Normally the operation of the module is quite reliable, but sometimes the one-sided copy enters the ADU and stops half way the paper path to the stacking tray. The reason is that when the operator removes jammed paper he opens the two entrance guides pos.8, but they are hinged very loosely and their material is soft steel. As a result they bend and the gap between the upper and lower guide plate becomes too narrow for the copy to pass.

Another problem occurs when the operator bends away the guide plates. There are two paper sensors there – jam switch pos.11 and paper empty switch pos.12. When the plates are bent, the flags of the sensors are not actuated, nor don't send signals to the receivers, causing paper jams. The solution is to bend back the plates just enough the sensors flags actuate the receivers but not so much as the gap between them will become too narrow:

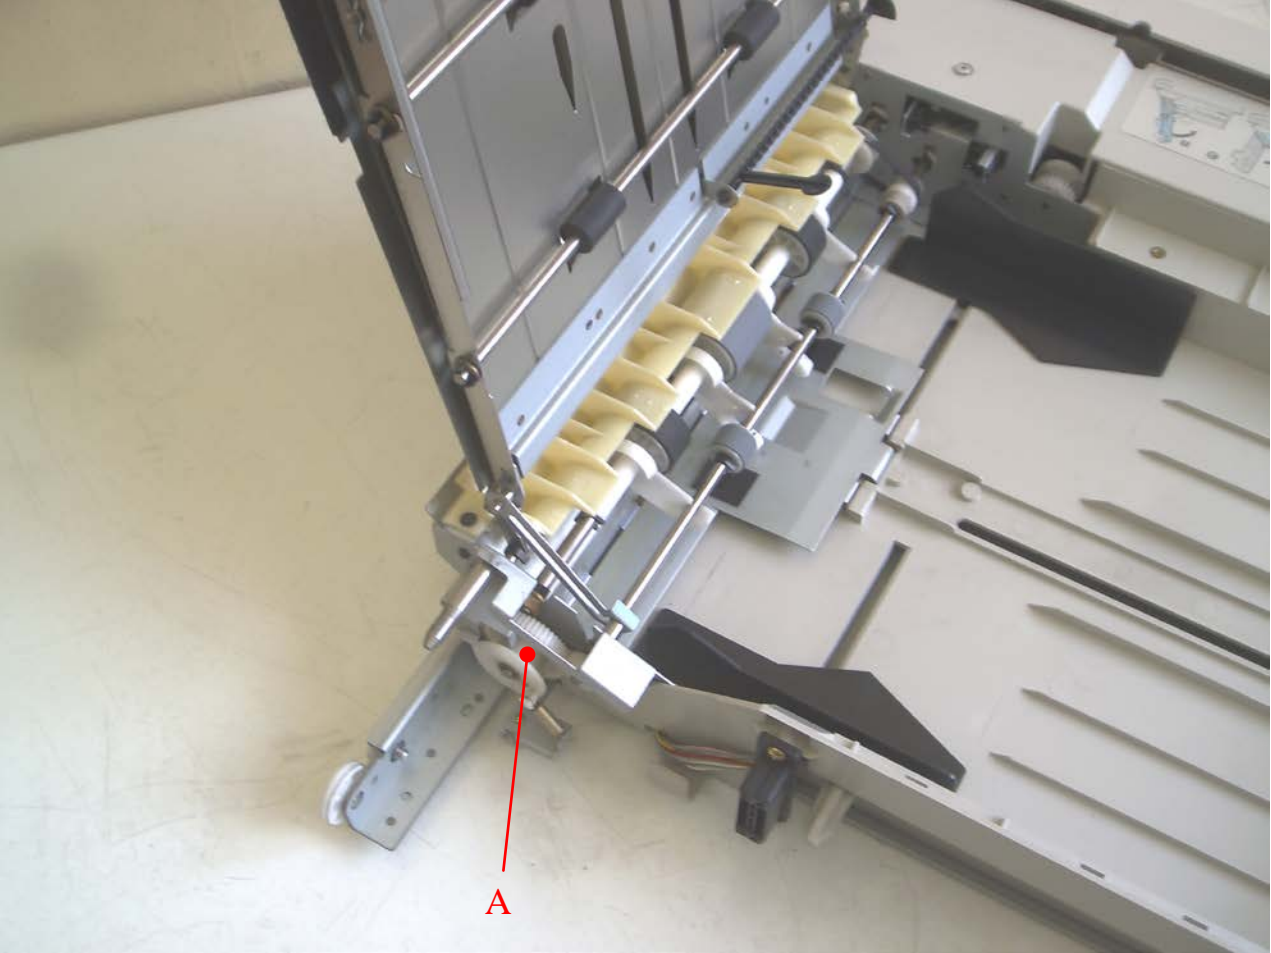
Another common problem is frequent paper jams, when the paper is stacked at the ADD paper tray and the copier executes paper pick up operation from the module. The cause for this problem is a spring clutch A, located at the back of the module. Sometimes it breaks off its spring or is just dirty and slips, causing the pick up roller not to rotate. The solution is to clean the clutch and lubricate the collars of the two hubs:

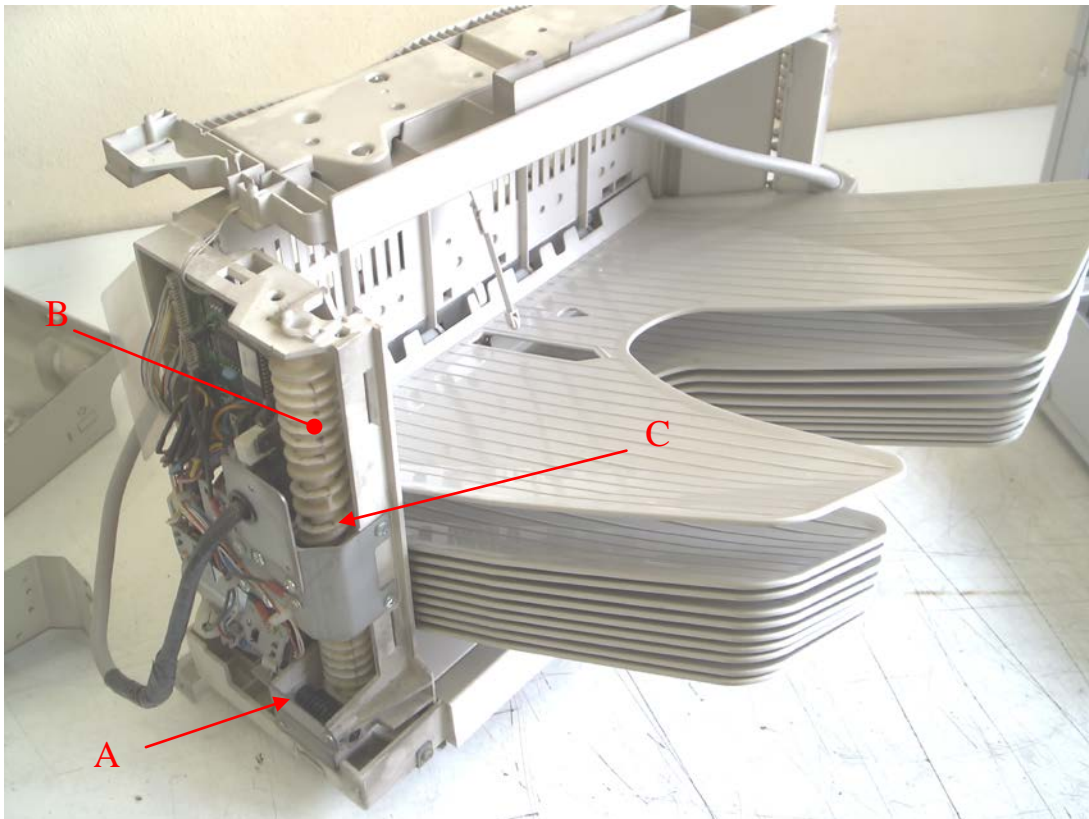
The sorters of these machines are very reliable and hardly ever break. The only problems with them are always caused by operators. They block the movement of the sorter's bins, causing them to snap off and loose their correct position in the guides, situated on both sides of the bins. The solution is to disassemble the covers of the sorter and disengage the left from the right bin guide. To do this remove the plate A and the gear behind it. Be sure that all bin guide rollers are situated one after another on both sides and that the bins are strictly horizontal. At this moment rotate the guides B until the reference holes C on them face towards you. Reattach the plate A and the gear:

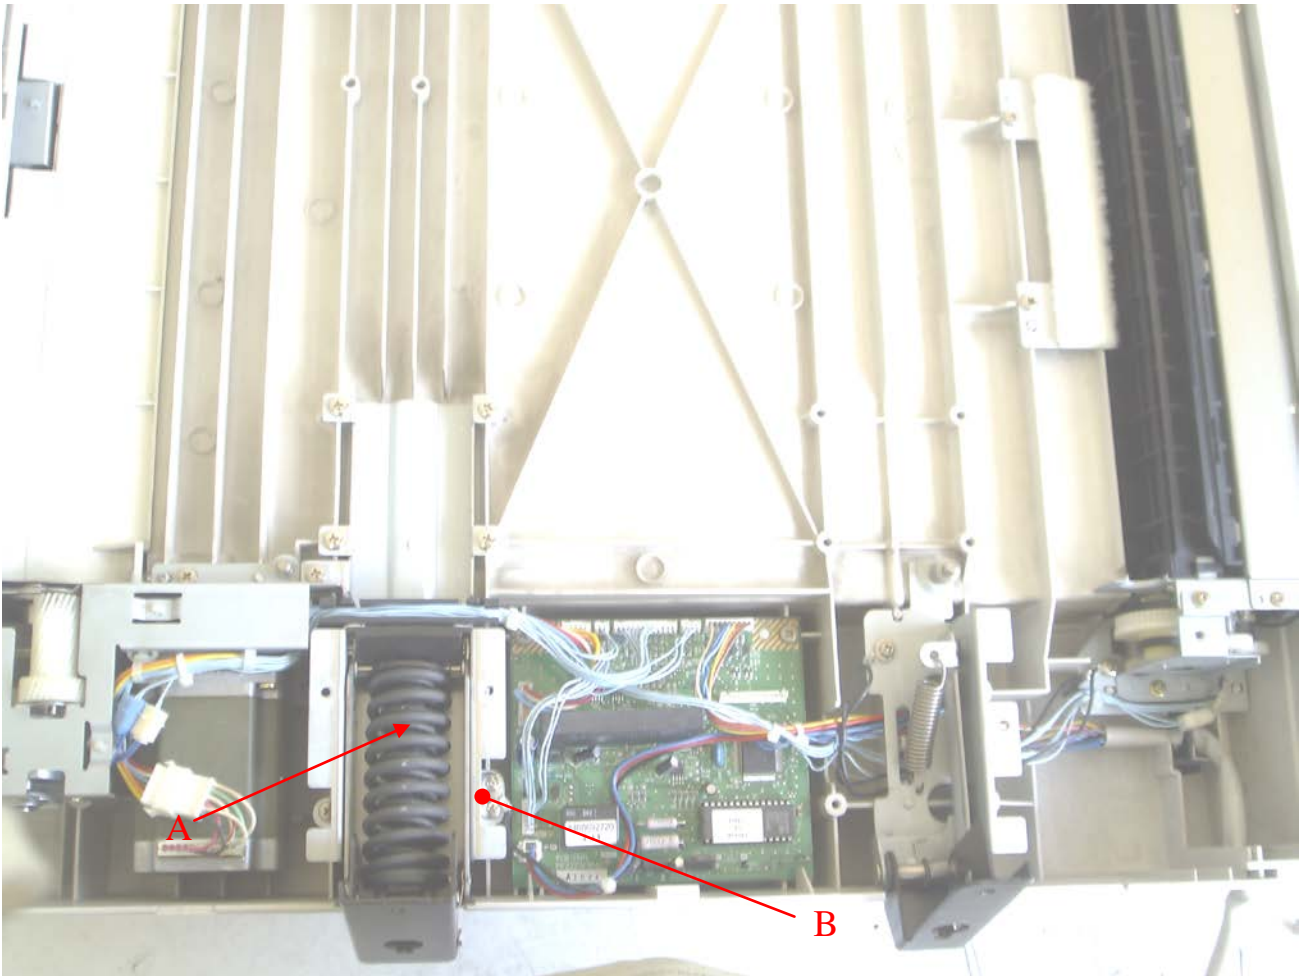
RADFs are also quite reliable modules with only a few hidden defects, which occur over many thousands of originals fed. The main problem is the open/close hinges of the module. They are made flexible to enable thick books copying from the original glass. When the RADF is closed, the hinges lift the cover. This is a useful mechanism, but in order to keep the cover in upright position when it is opened, there is a shock absorber and a spring A, built in the bigger hinge B. Very often the absorber fails and when the operator closes the cover the rear end of the module remains slightly lifted. When an original is fed it is transported by the RADF's transport belt, but it is skewed because of the uneven pressure exerted from the cover. Sadly there is no solution to this problem, but to replace the whole hinge assembly, which is quite expensive:

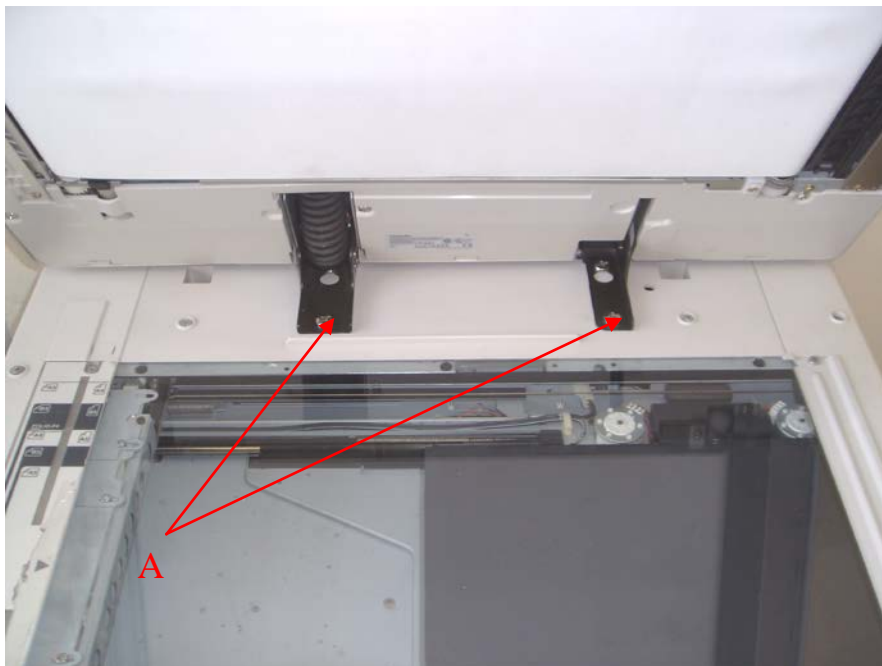
Another common problem with RADFs is when the copier tells the operator to close the module, but it is already closed. This happens when the machine is moved from one location to another by pushing it through the RADF module, rather than the machine body itself. The hinges move slightly and the built sensor for opened/closed cover is not actuated. The solution is to simply readjust the screws A of the hinges in the boundaries marked on them:

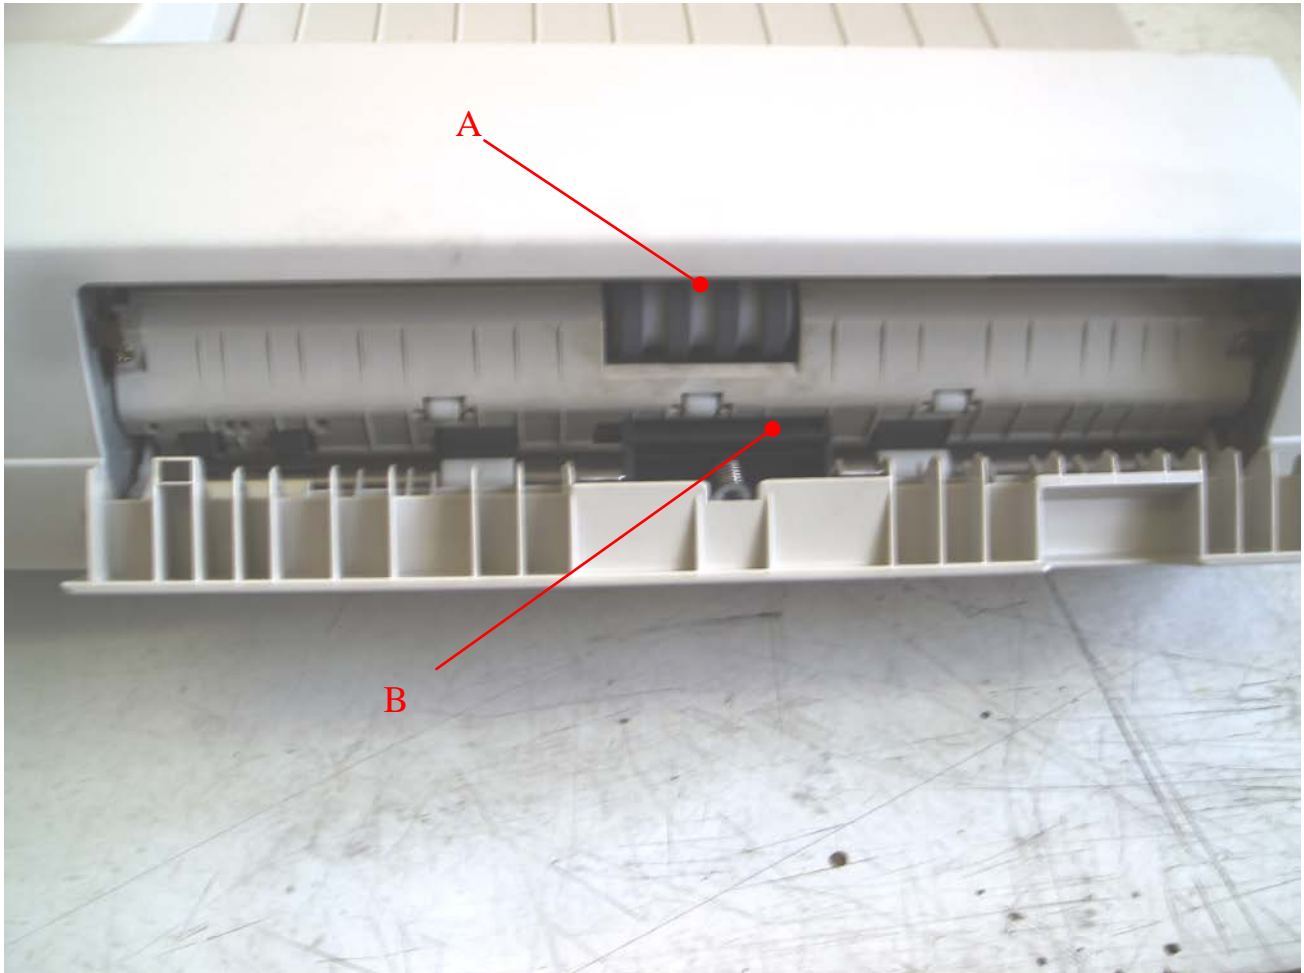
From time to time the copier will tell the operator to remove the originals from the RADF in order to copy from the original glass, but there are simply no originals in the module. This is caused by the paper empty sensor A stuck in one position. The solution is to gently adjust it in place.

Sometimes the originals are fed skewed to the original glass. This is caused by the separation pad rubber piece B. It is attached by a double sticking tape and becomes displaced from time to time. Simply reattach it with new tape:

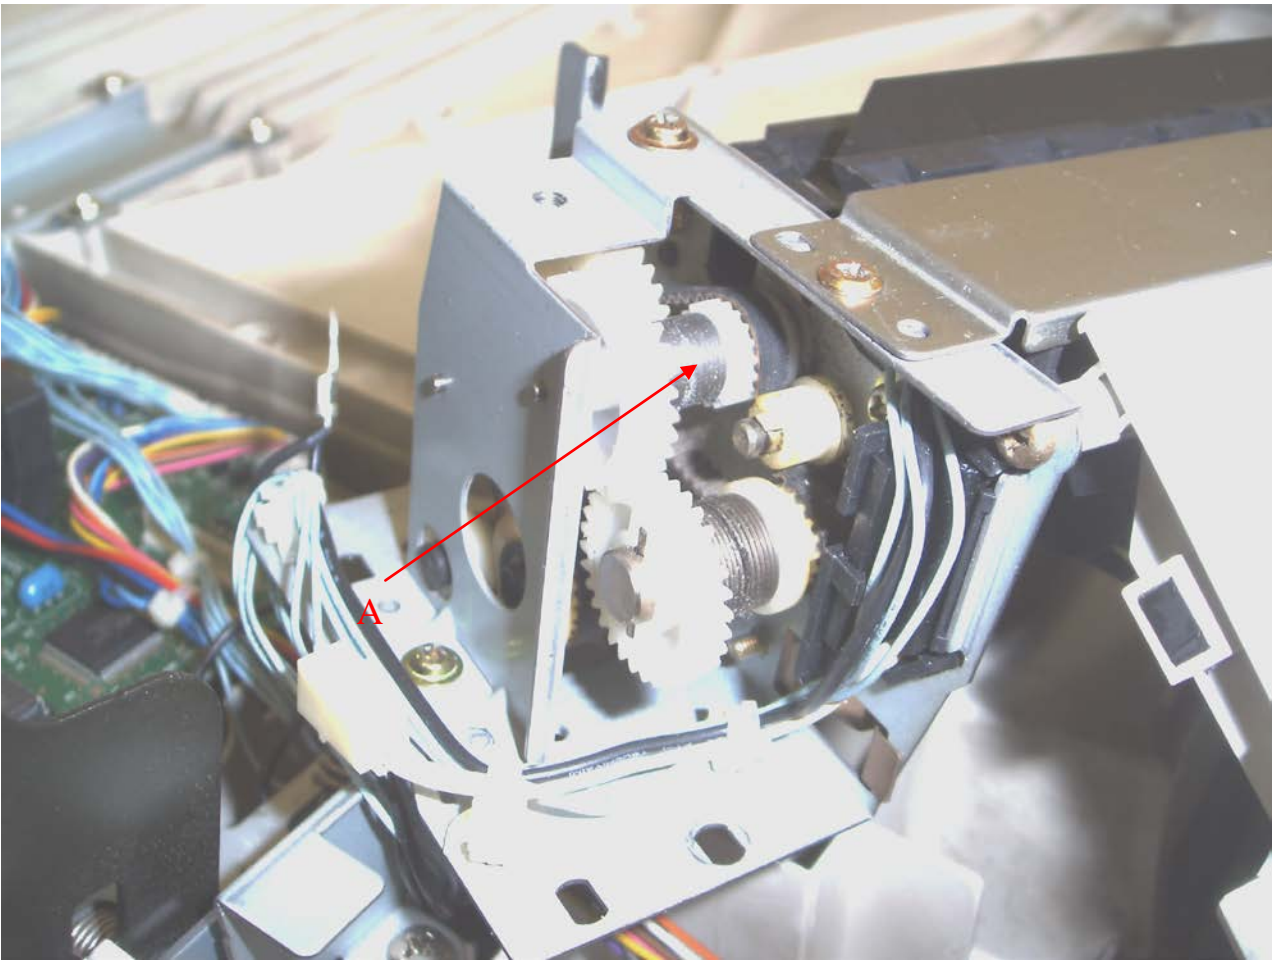
Finally there is a hidden mechanical defect in the reversing mechanism of the module, when copying two sided originals. The RADF would feed and copy normally one sided originals and transport and exit them normally, but when the original has to be reversed in order to be copied from its other side is jams at the reversing mechanism. The defect is caused by a failed clutch A in the mechanism:
