RESEARCH ON THE SAFETY LEVEL OF THE EXISTING ELECTRIC TRACTION ELEVATORS

Tihomir DIMITROV, Georgi ILIEV, Kalin CHUCHUGANOV, Pavel DAVIDOV

Engineering logistics, material handling, building and roadbuilding machines department, Technical University-Sofia, Bulgaria

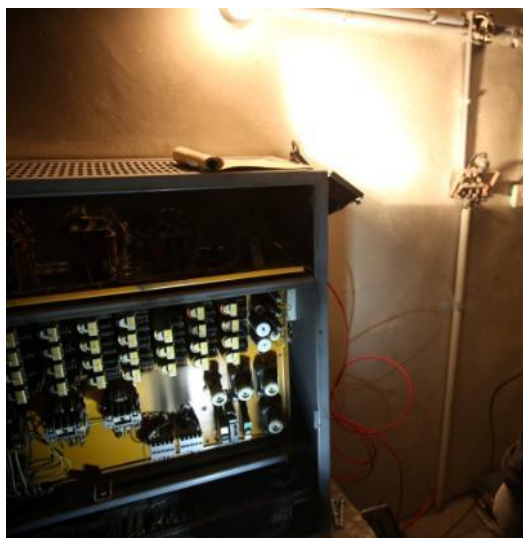
When making comparison between these units and comparable solutions of other manufacturers of the same years, the trend mentioned in point 2.13 above is clearly visible. But the practice since a lot of years shows no serious safety issues with these types of controllers. We have to mention only one safety related thing here. There is one type of the controllers used, which are without third contactor used as a safety device against contacts welding. Theoretically this is a safety issue, and according to the current legislation this is nonconformity.

Picture 2: Relay controller frequently used

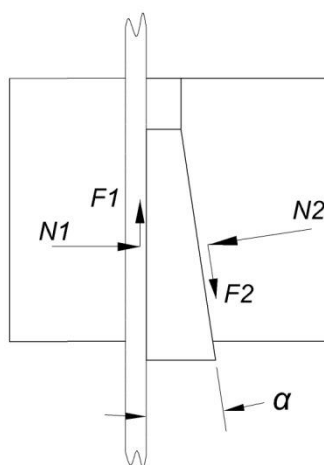
Figure 3: Schematic of forces of wedge type safety block

The last well known formula explains why the dependence of both coefficients of friction has to be fulfilled in order to have working device. Also, in order to achieve the higher coefficient of the working surface in most cases the wedge is toothed or channelled, as well as hardened to achieve higher wear resistance. The last thing is very important in
