TOSHIBA THE 60TH SERIES ANALOG COPIERS – A FINAL ANALYSIS OR WHICH ARE THE MOST COMMON AND MIND SCRATCHING PROBLEMS IN THESE MACHINES.

TOSHIBA 1350/1360/ 1370

TOSHIBA 1550

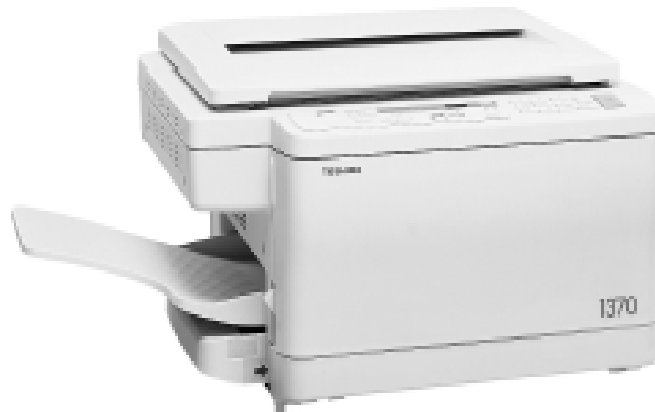
Normally this is a very reliable and tough small copier. In my field experience I've had least problems with these machines, even though some of them were overworked and the copy count was well over 300 000 copies. Given proper maintenance the consumable parts may live up to twice their predicted life. However there are some problems with these machines:

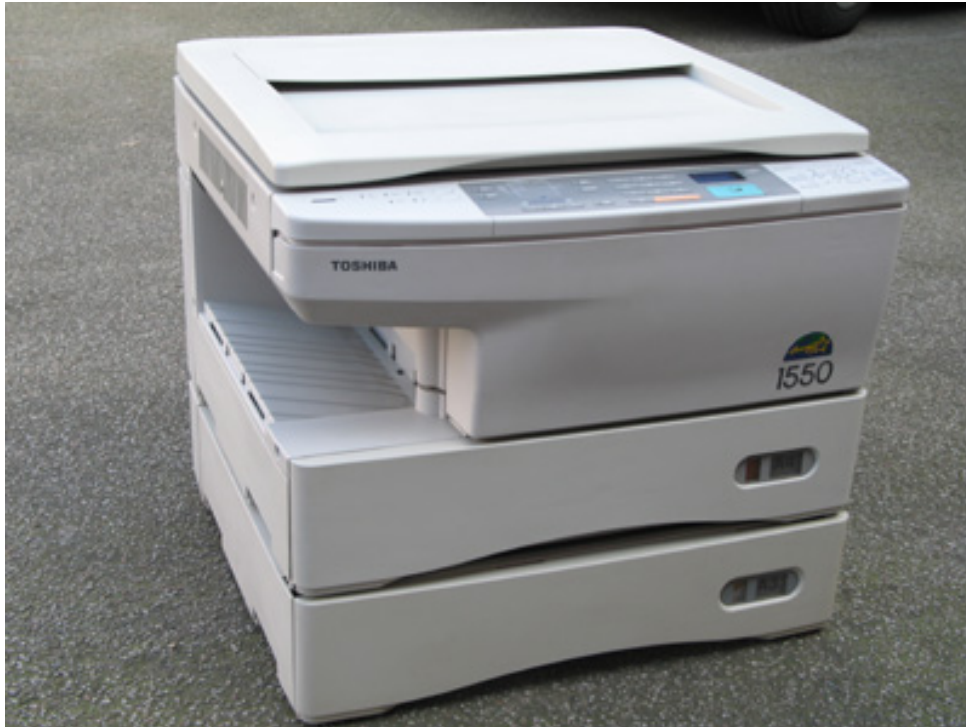
As I mentioned in previous articles, this model is the most loved and most hated among the service technicians. There are so many problems with this model, but if you catch them on time it is quite sure it will work for more than half a million copies and more.
