TOSHIBA THE 60TH SERIES ANALOG COPIERS – A FINAL ANALYSIS OR WHICH ARE THE MOST COMMON AND MIND SCRATCHING PROBLEMS IN THESE MACHINES PART 2.

This is the final article about Toshiba's 60th series analog copiers. In the article you will find the most common problems, found in the models 2060, 3560 and 4560, as well as in their options – duplexing unit, sorters and automatic document feeders.

TROUBLESHOOTING THE 2060 3560 AND 4560 MODELS

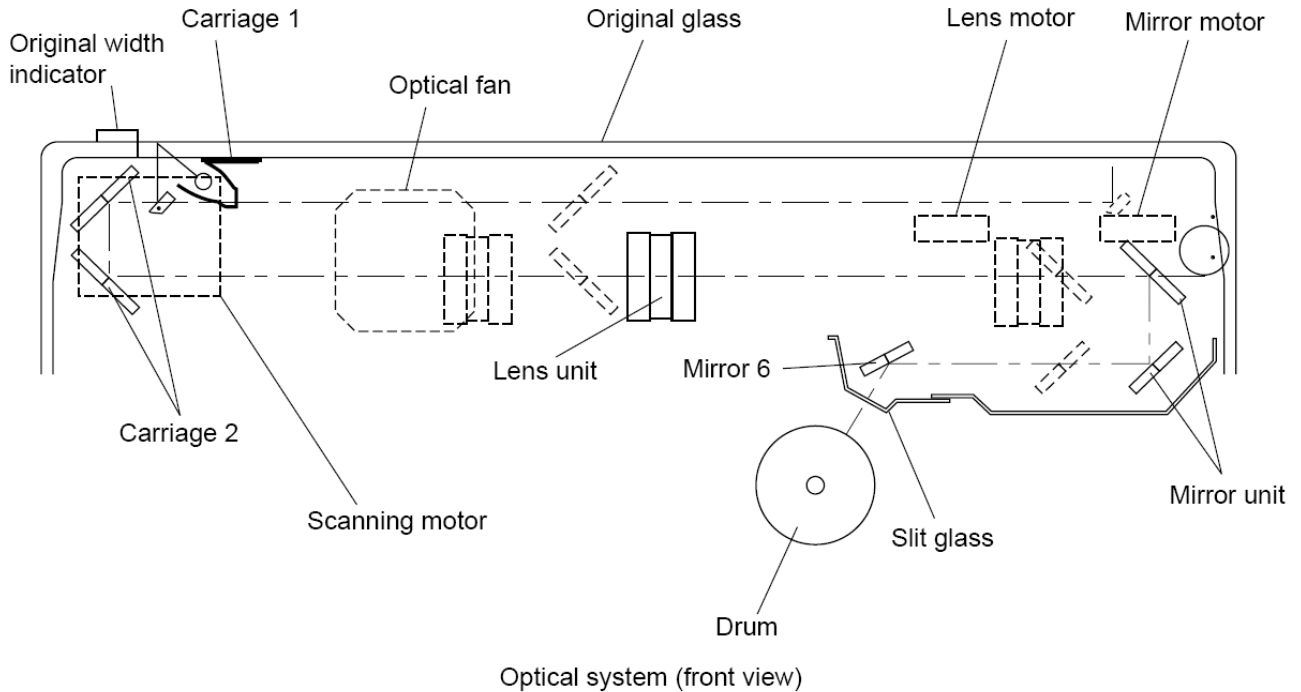
The biggest issue here is to have to change the optics carriages drive wire, but it happens very rarely:

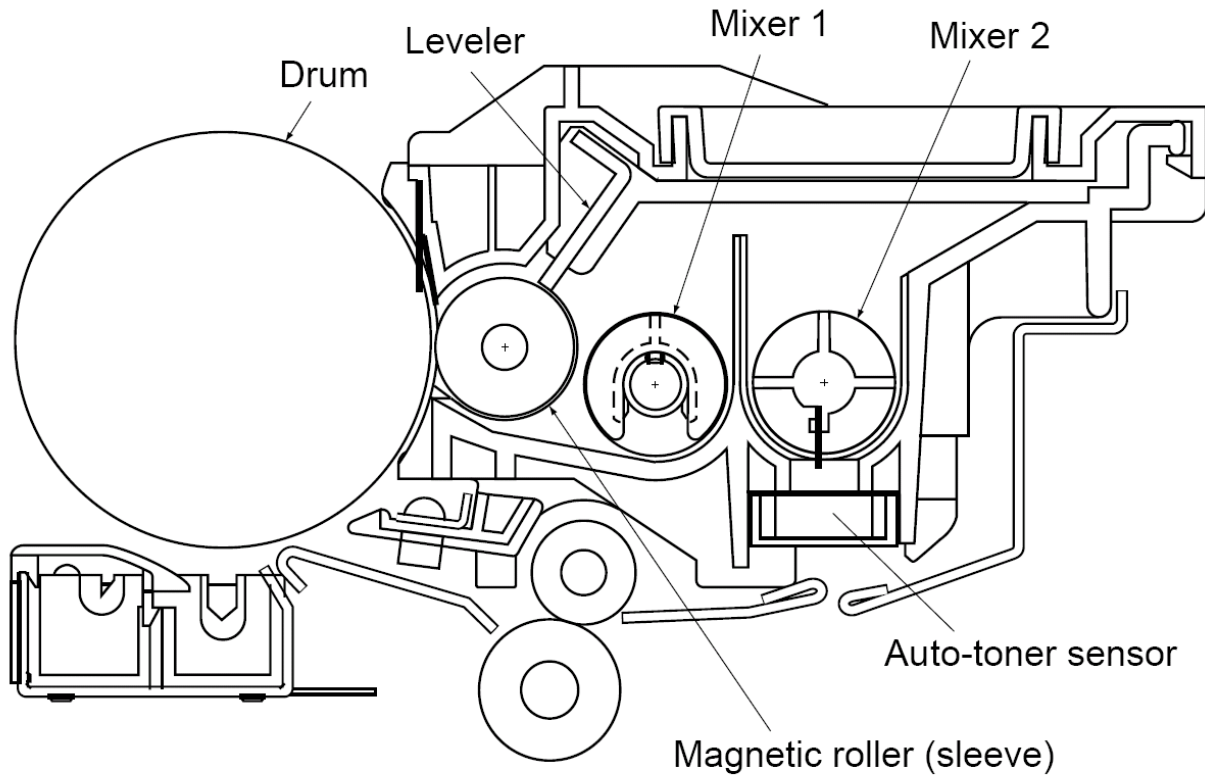
Front side sectional view

This is the most troublesome module in the copier. It is very important to know its weak spots, because it affects other parts, around it – the opc drum, the main gears and the high voltage boards. The construction of the module is explained on the following figures:

The first problem you may encounter is the blocking of the magnetic roller. It happens when around 500 to 800 thousands copies are made. The roller blocks the torque to the module and the developer drive gear G24 may break, or the timing belt 2M96 may wear and start to loose pitch. The problem arises from the magnets inside the roller. They are shaped like edges and are glued around the center shaft. When one of them falls off the shaft, it rubs against the magnetic roller sleeve and acts like an edge, blocking the rotation of the sleeve. The solution is to replace the magnetic roller and always check that the developer module rotates free, by hand cranking the module.

Another common problem is spillage of developer material from the mixers shafts 1 and 2 at the rear end of the module. The shafts rotate inside the developer hopper, but receive torque through the gears at the rear end. The shafts go through the walls of the hopper and are secured by seals A. If these seals leak, the developer damages the bronze bushings B and the driving teeth of the module. This happens always at the rear end seals. So it is important to check these seals, every time you perform a periodical maintenance of the module.

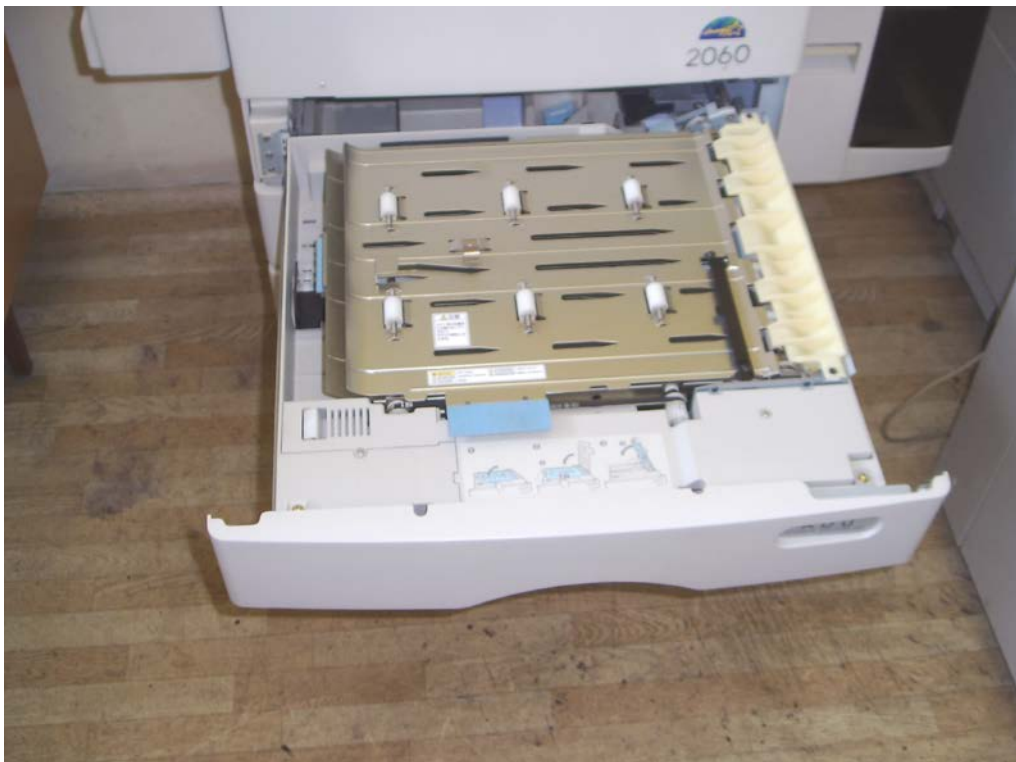
ADU – automatic duplexing module

The construction of the module is shown on the figure bellow. Normally the operation of the module is quite reliable, but sometimes the one-sided copy enters the ADU and stops half way the paper path to the stacking tray. The reason is that when the operator removes jammed paper he opens the two entrance guides pos.8, but they are hinged very loosely and their material is soft steel. As a result they bend and the gap between the upper and lower guide plate becomes too narrow for the copy to pass.

Another problem occurs when the operator bends away the guide plates. There are two paper sensors there – jam switch pos.11 and paper empty switch pos.12. When the plates are bent, the flags of the sensors are not actuated, nor don't send signals to the receivers, causing paper jams. The solution is to bend back the plates just enough the sensors flags actuate the receivers but not so much as the gap between them will become too narrow:
